Confidential Inspection Report

LOCATED AT:
6370 E Royal Palm Rd
Paradise Valley, AZ 85253

INSPECTED ON:
Monday, September 13, 2021

Inspector, Rich LeGrand 53350
Alliance Property Inspections 14747 N. Northsite Blvd Set 111-292 Scottsdale, AZ
85260

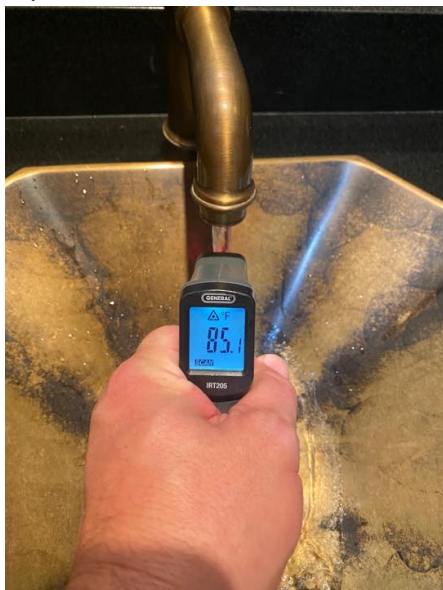
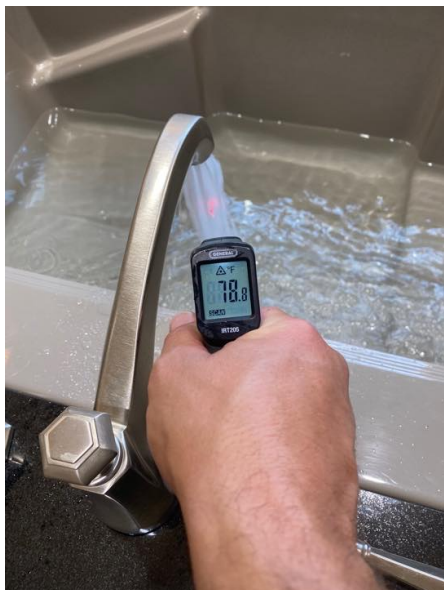
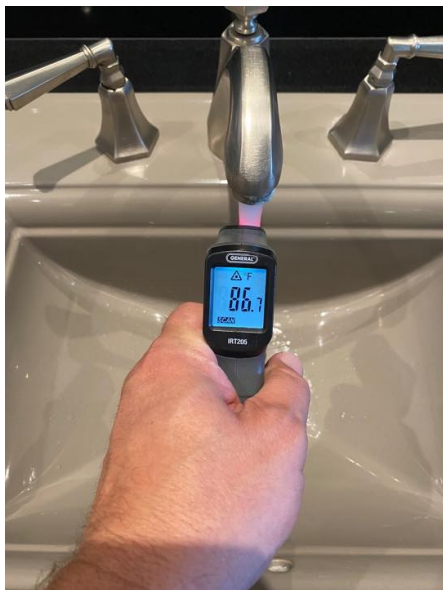
s-270: Water heater for the master side of the property was not producing hot water, further evaluation and repair is recommended.

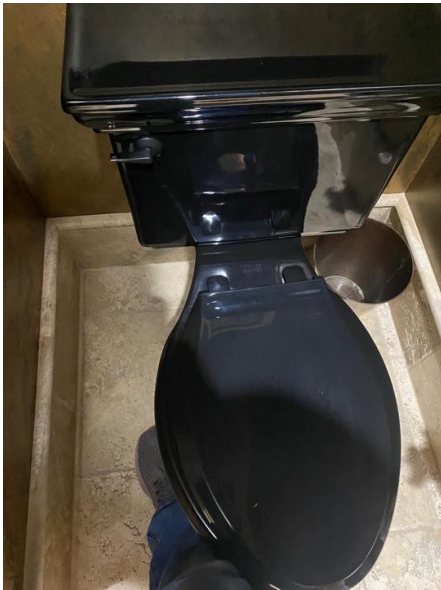
WARN s-280: The toilet is loose at the floor. While no damage was evident, this condition should be taken care of so that leakage does not develop and cause damage. We recommend that the toilet be removed and rebolted with a new wax seal.

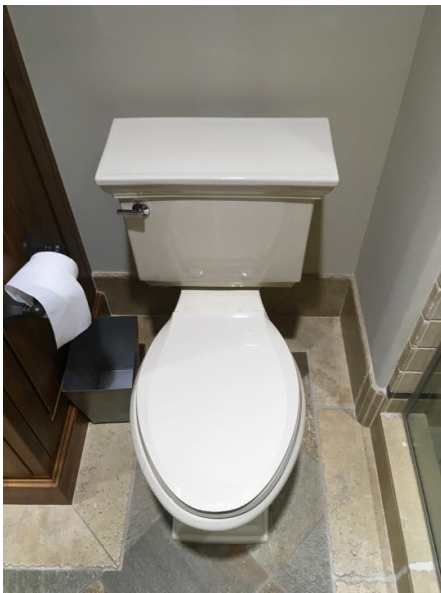
Office

WARN s-281: The toilet is loose at the floor. While no damage was evident, this condition should be taken care of so that leakage does not develop and cause damage. We recommend that the toilet be removed and rebolted with a new wax seal.

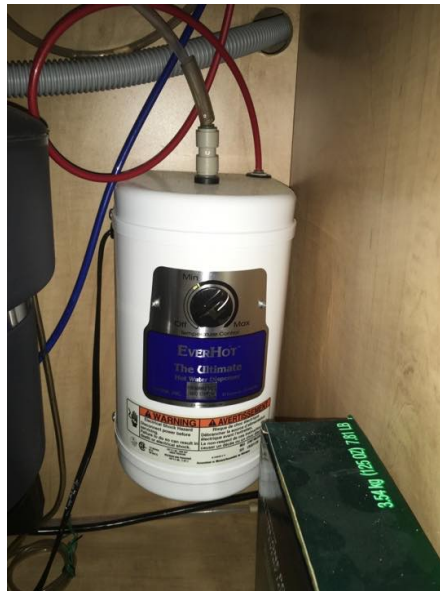
Insta-Hot faucet

WARN s-314: The faucet is leaking. We recommend that it be repaired or replaced.

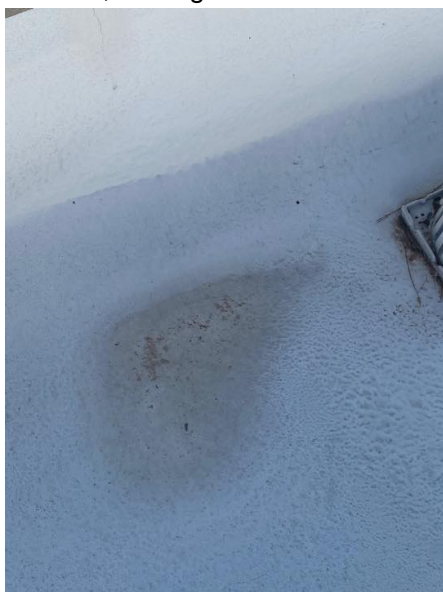
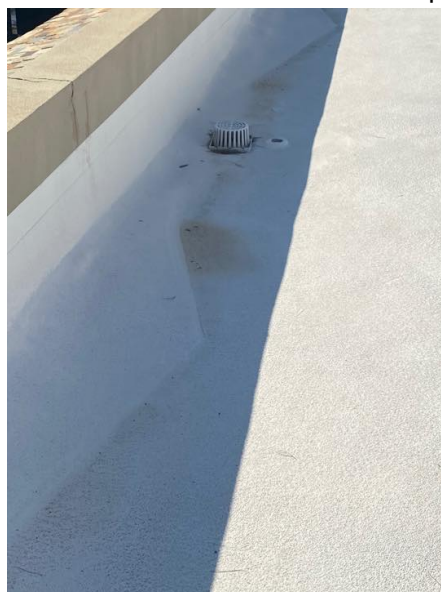
39: There is evidence of ponding at. The presence of shallow ponds of water immediately after rains are not unusual, but regular maintenance of these areas is vital to avoid a buildup of rotting vegetation.

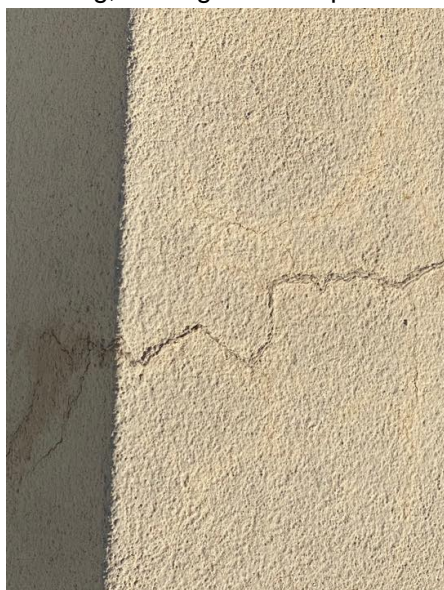
42: The visible surfaces of the parapet are weathered and in need of maintenance. We recommend repair, caulking, sealing and/or replacement of the exposed materials to maintain a waterproof condition.

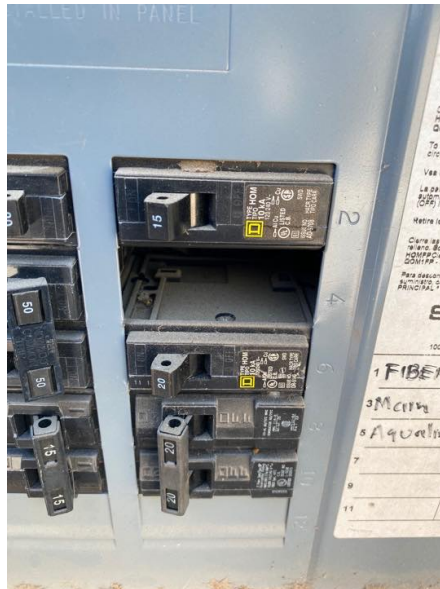
78: There are holes in the subpanel where 'knockouts' have been removed and left open. This is not an approved practice and we recommend the holes be closed with approved filler plates.

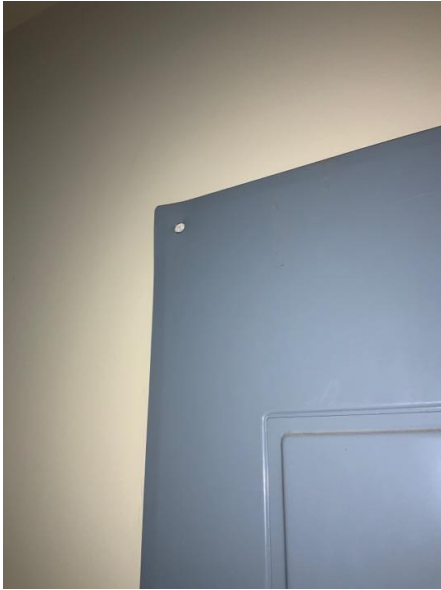
79: Some of the subpanel cover screws are missing. We recommend installation of proper blunt-end screws.

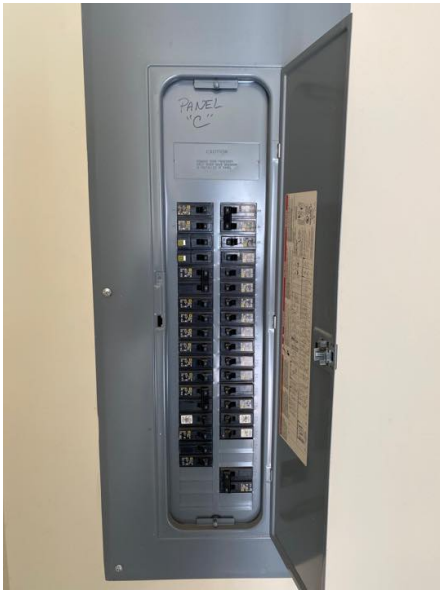
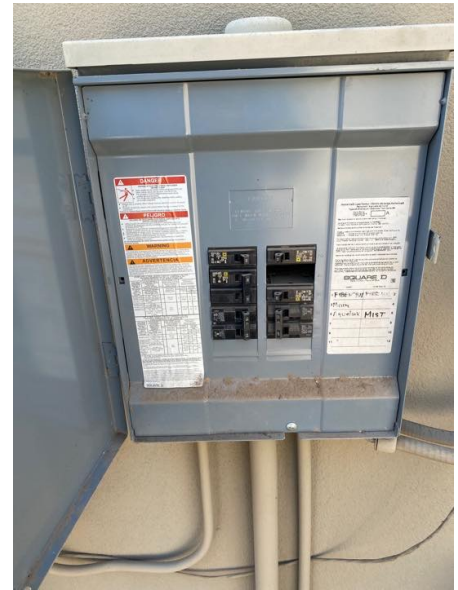
81: Neutral wire in sub panel A has not been properly re identified, recommend wrapping the wire with black electrical tape to identify.

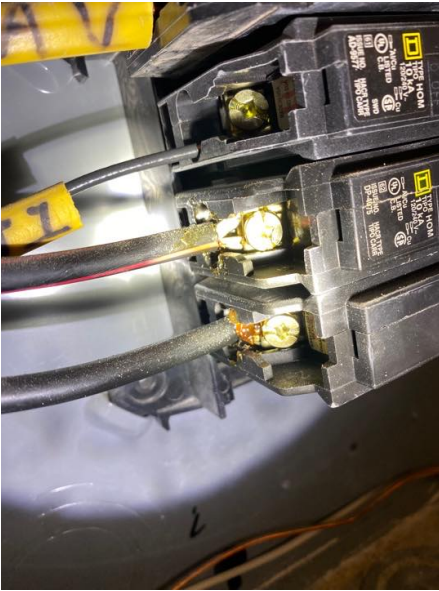
Pool equipment

84: We found underfusing in the subpanel. This is not a hazard but, depending on the connected loads, may be an annoyance because of frequent and unnecessary tripping of the circuit. We recommend installation of appropriate fuses or breakers.

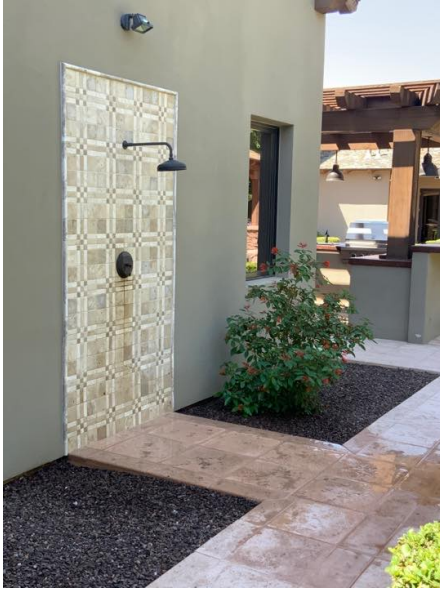
110: The exterior pool shower does not have a proper drainage system, potentially allowing water to collect around the foundation. Recommend further review and repair as necessary.

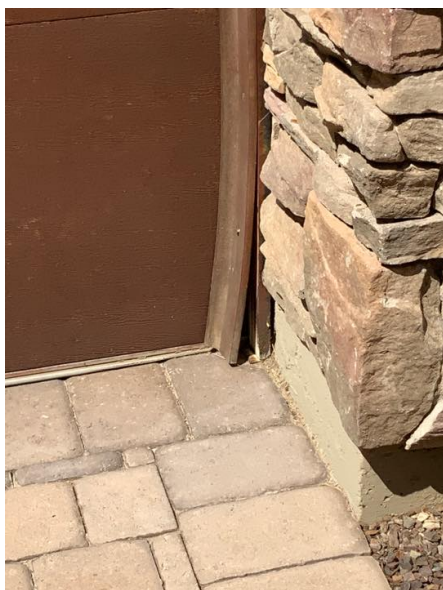
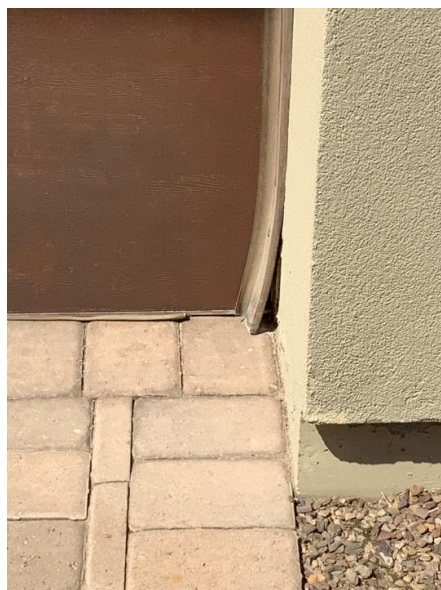
131: The trim is loose or improperly secured. We recommend it be resecured in accordance with accepted standards.

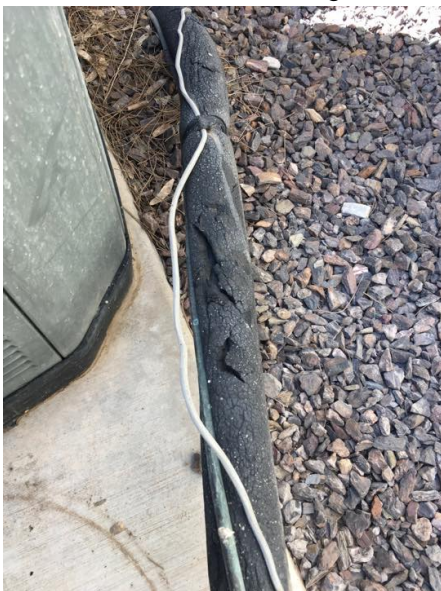
Right side

169: Insulation is deteriorated and missing from a portion of the refrigerant lines near the condensing unit. We recommend that all missing insulation be replaced to increase energy efficiency.

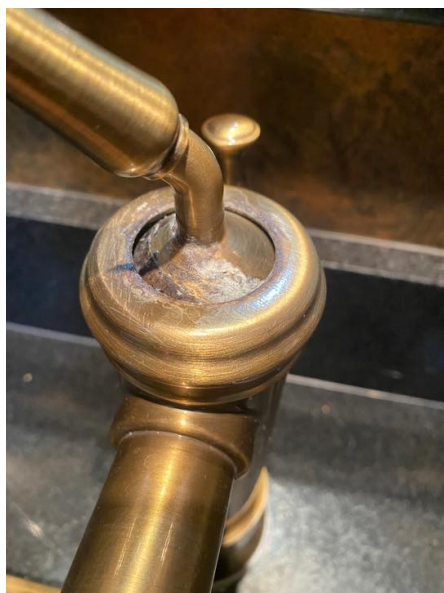
216: The plumbing fixtures, although operating, are deteriorated. Routine maintenance will keep them functional and maximize their useful life.

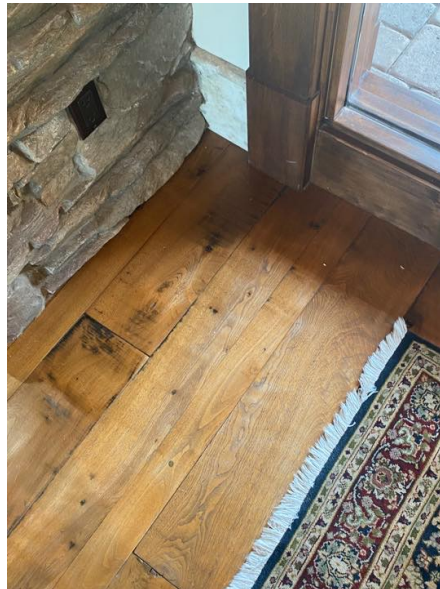
230: Portions of the floors are worn. We recommend refinishing to protect the wood and for a better appearance.

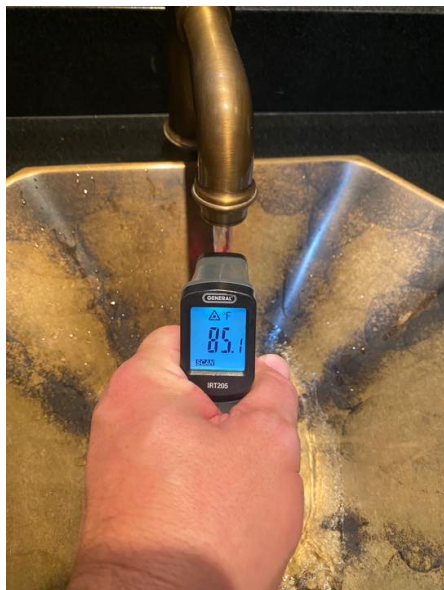
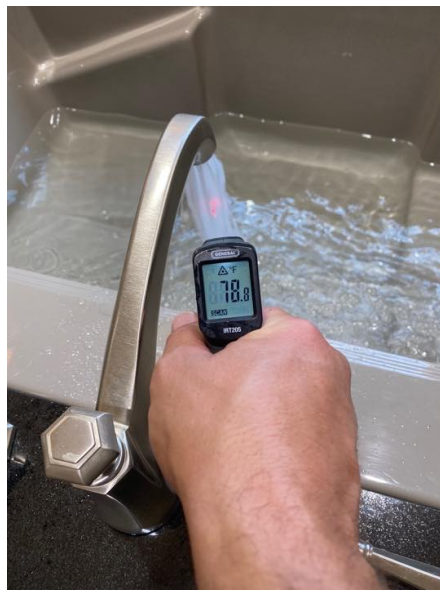
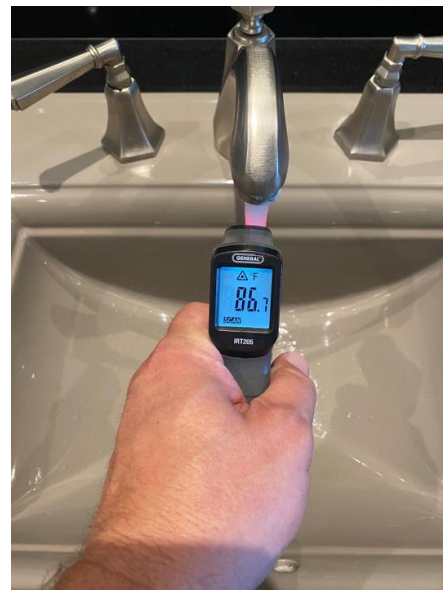
270: Water heater for the master side of the property was not producing hot water, further evaluation and repair is recommended.

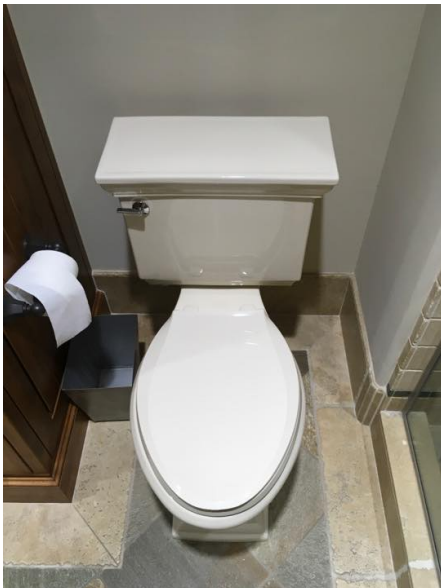
Office

WARN 281: The toilet is loose at the floor. While no damage was evident, this condition should be taken care of so that leakage does not develop and cause damage. We recommend that the toilet be removed and rebolted with a new wax seal.

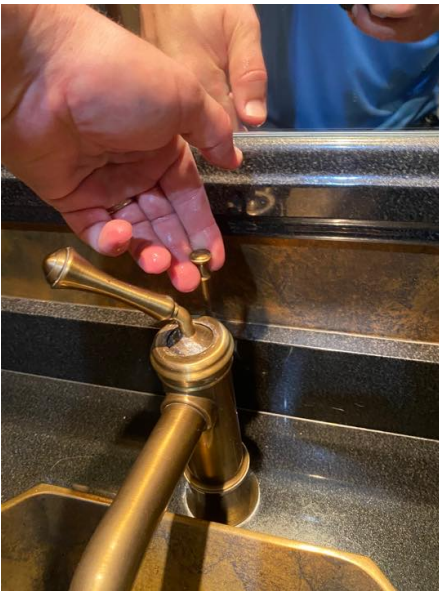
284: The drain stop is defective. We recommend it be repaired or replaced.

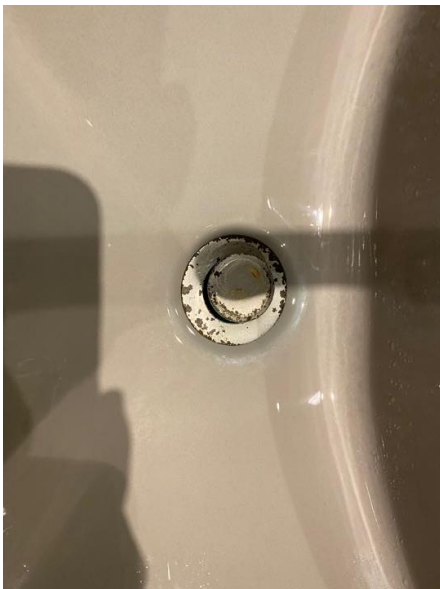
Casita

287: Corroded collar, recommend repair.

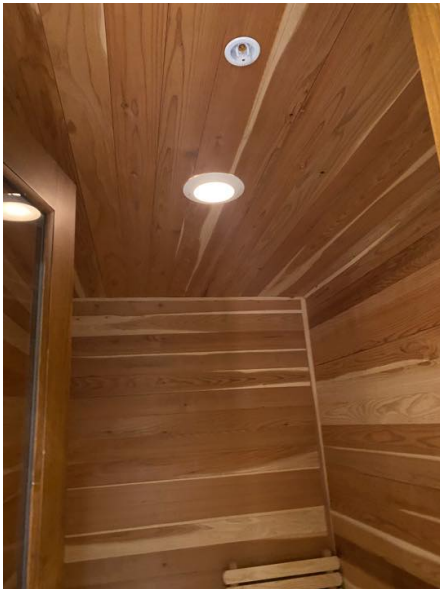
295: Sauna like would not turn off, recommend repair.

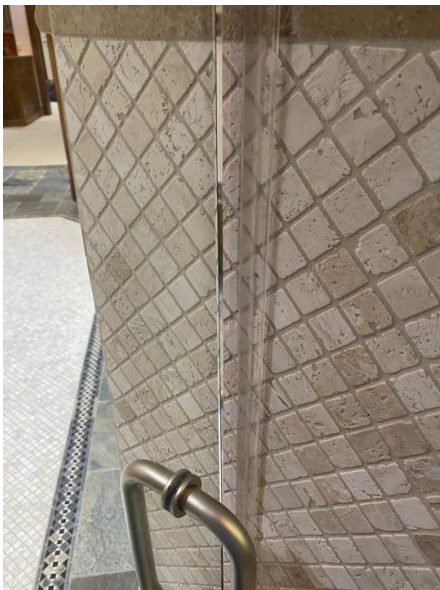
299: Master shower door does not fully close, recommend repair as this is a steam shower.

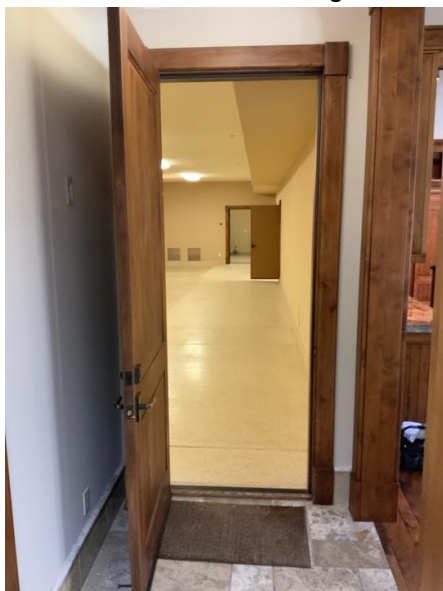
WARN **UPG** **312:** The door between the garage and the living space is of fire resistive construction. However, the door is not self-closing. We recommend the door be upgraded by installing a spring hinge or an automatic closer to maintain the designed fire rating.

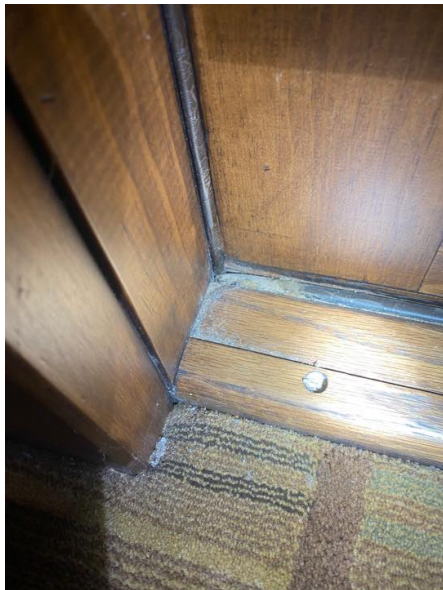
336: Minor water stains were observed on the base of the office doors, recommend monitoring.
