Confidential Inspection Report

LOCATED AT:
6370 E Royal Palm Rd
Paradise Valley, AZ 85253

INSPECTED ON:
Monday, September 13, 2021

Inspector, Rich LeGrand 53350
Alliance Property Inspections 14747 N. Northsite Blvd Set 111-292 Scottsdale, AZ
85260

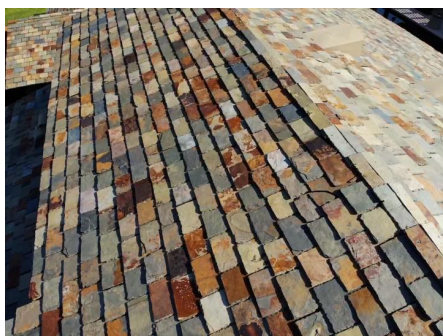
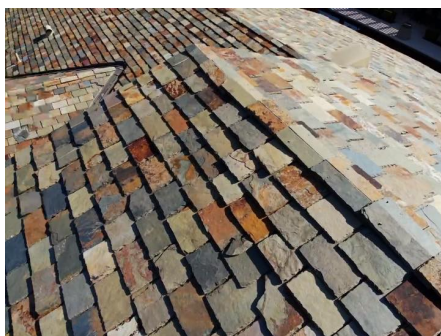
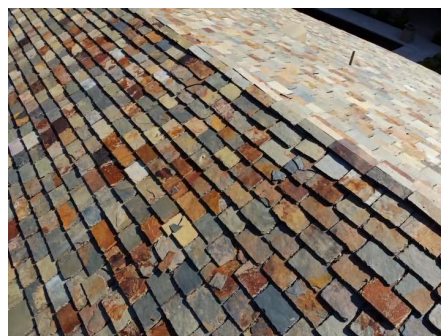
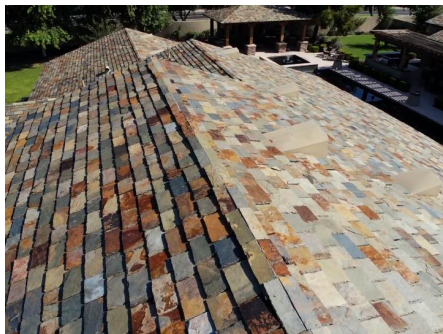
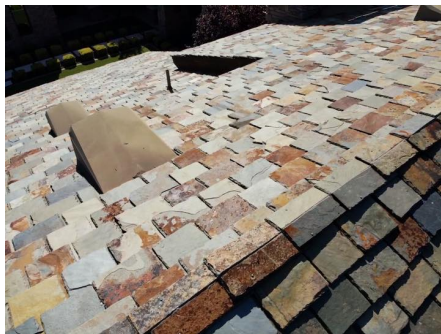
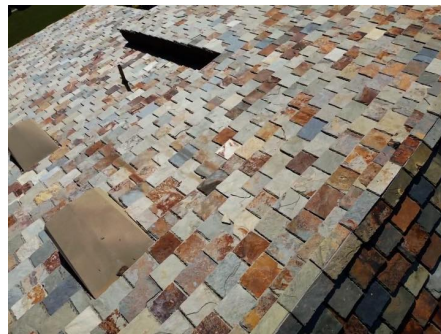
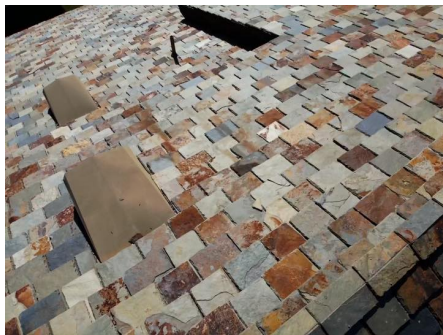
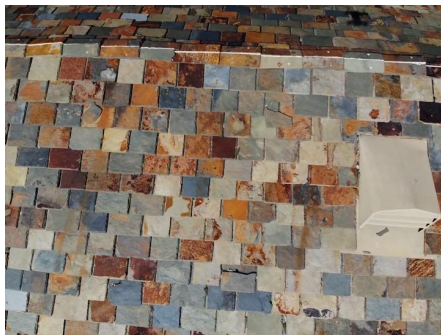
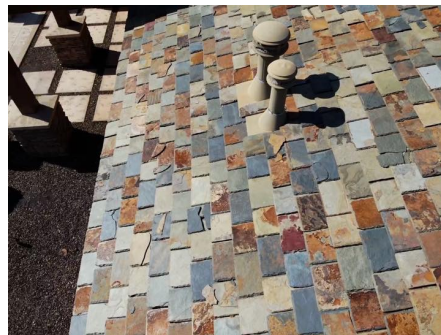
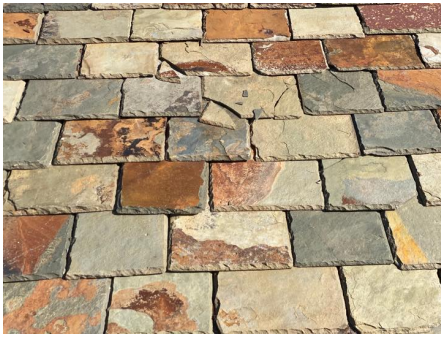
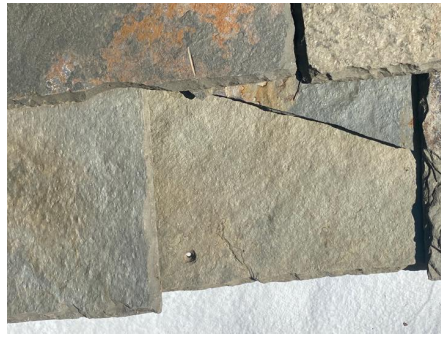
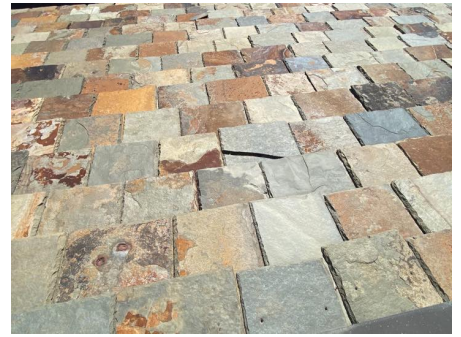
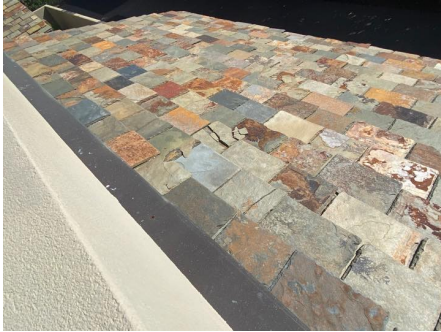
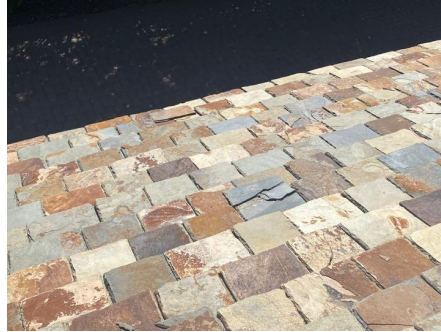
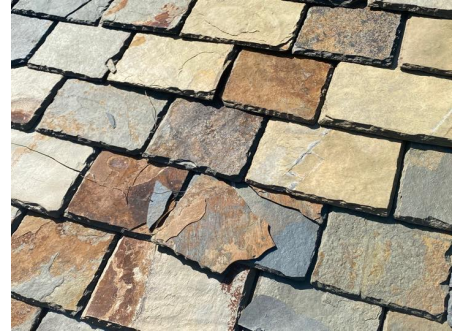
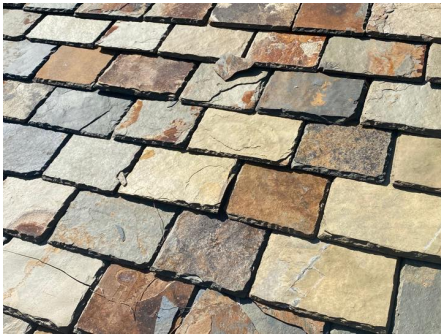
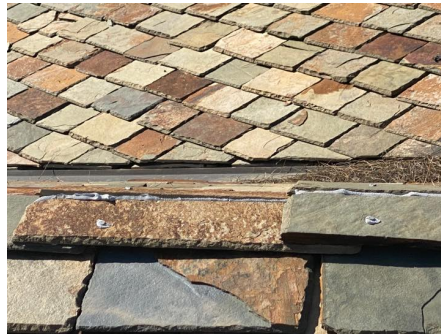
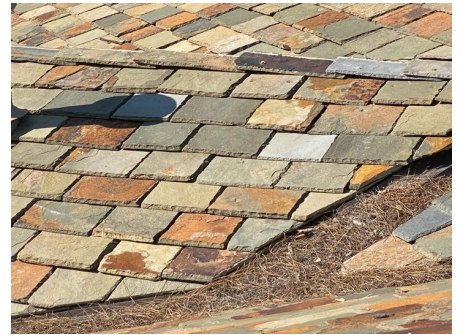
EVAL s-18: There are individual cracked, chipped and displaced tiles along the ridge and/or in the field. Recommend further evaluation.

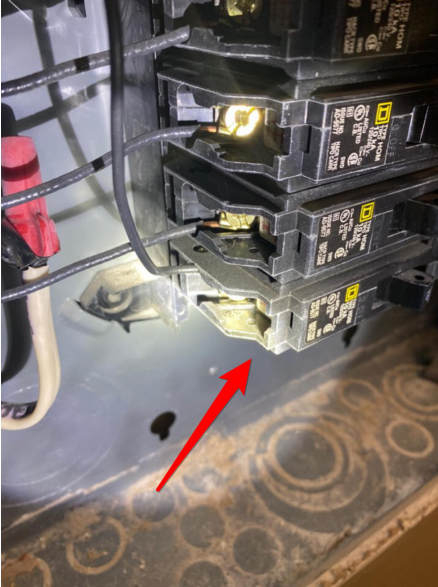
Panel D

DNGR s-83: We found over-fusing in the subpanel. This allows excessive current(heat) to flow through the conductors(wire) before the overcurrent protection devices(breakers) 'trip'. This is a safety hazard because it allows conductor overheating.

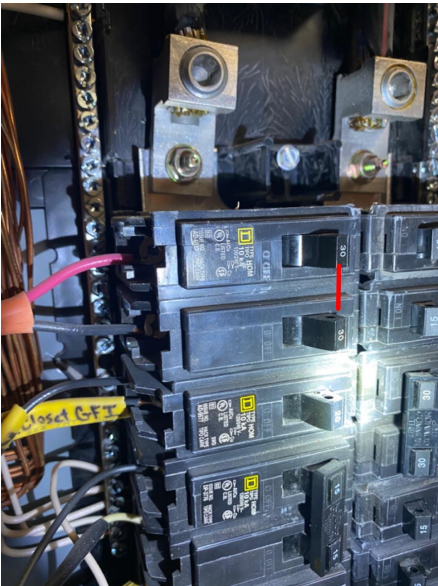
Panel D

s-86: Missing breaker handle tie, recommend repair.

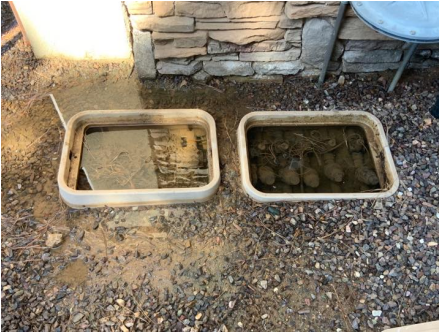
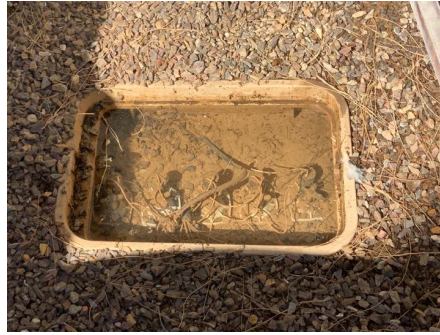
EVAL s-109: Leaks were observed in the system at the front irrigation valves. Recommend further evaluation by a irrigation professional and making all necessary repairs before using the system.

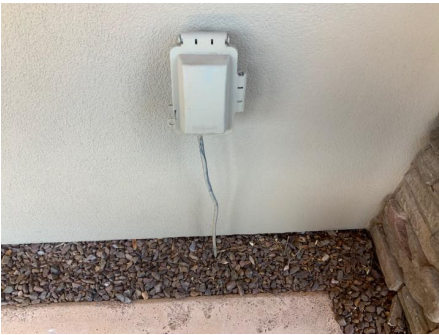
Backyard

s-111: The buried wiring to the outdoor lighting is not an approved installation. In this case, the wiring is vulnerable to physical damage and should be encased in proper underground conduit. We recommend it be replaced with an approved material.

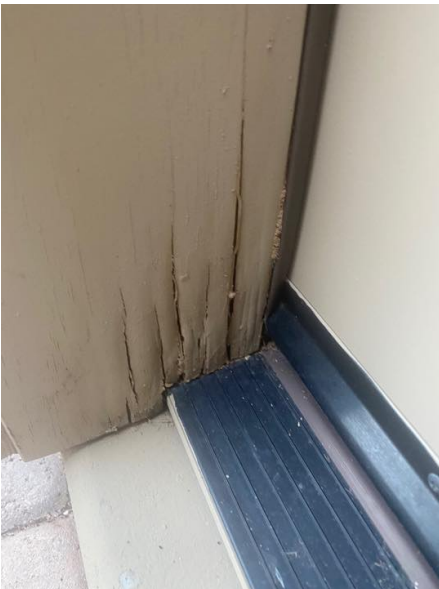
s-116: The garage exterior door is deteriorated. We recommend it be repaired or replaced.

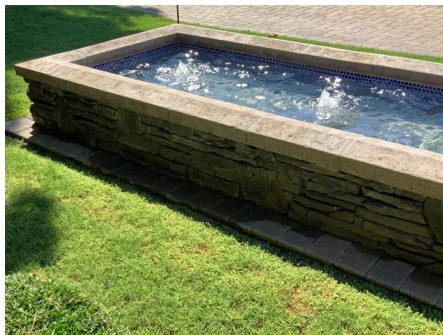
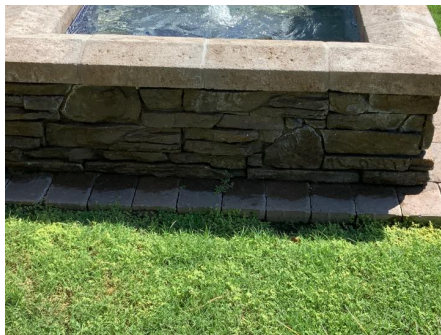
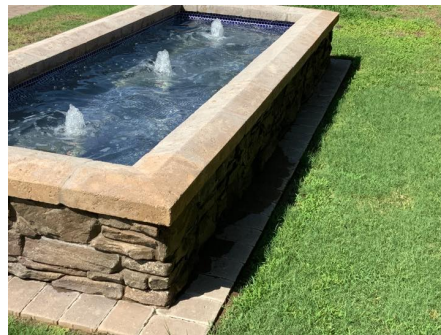
s-137: Although fountains are not part of a standard home inspection, it appears they are leaking. Recommend further evaluation and repair as necessary.

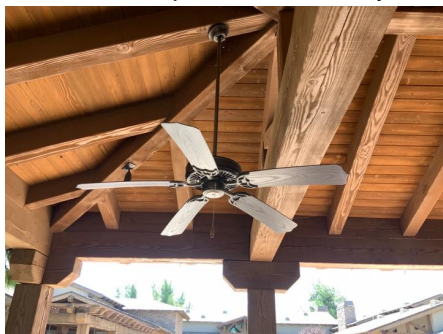
Ramada

s-139: One or more outdoor fans were not operational or the remote was not located. Recommend further review and repair as necessary.

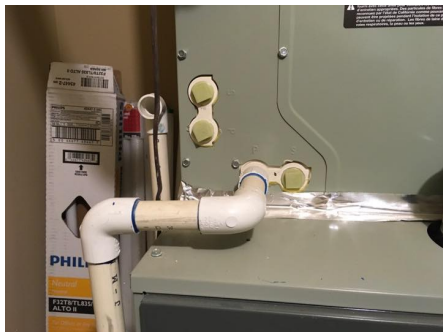
Garage

WARN s-164: The secondary condensate drain line lacks a drain fitting in the air handler that allows condensate to properly drain into the catch pan, should the primary drain become plugged up. We recommend modification in accordance with present standards.

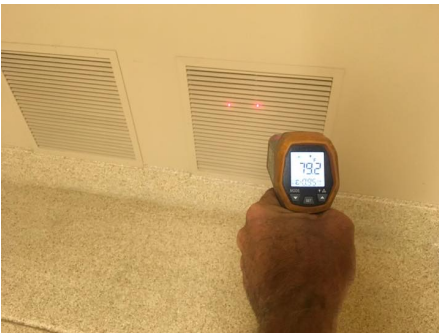
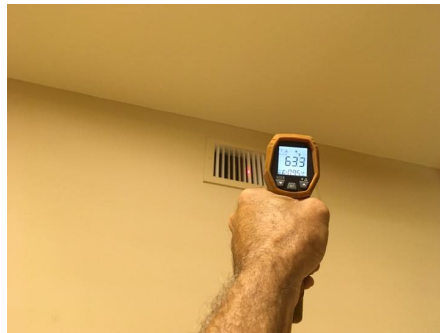
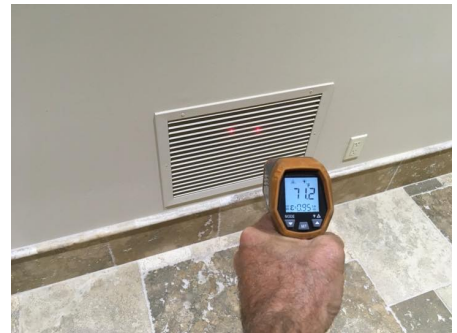
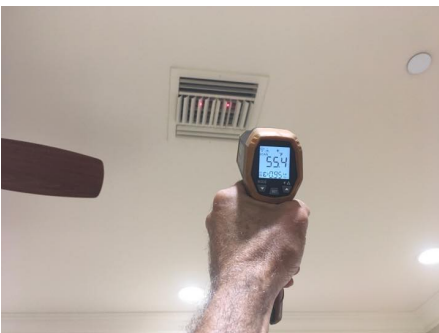
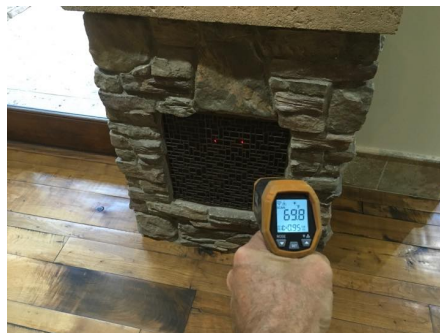
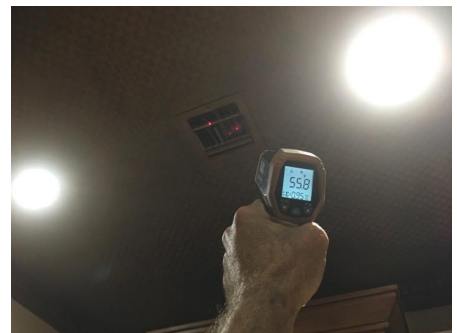
s-176: The ambient air test was performed by using a thermometer on the supply and return of HVAC system. The thermometer is used to determine if the difference in temperature of the supply and return air was between 14 and 25°. Temperature differences in this range indicate the unit is performing at an efficient rate. The temperature splits at the time of the inspection were as follows indicating which units were operating in an efficient range and which need further evaluation and possible repair.

Right front: 13°F - Further evaluation recommended

Left front: 13°F - Further evaluation recommended

Master suite: 7°F - Further evaluation recommended

Left rear: 13°F - Further evaluation recommended

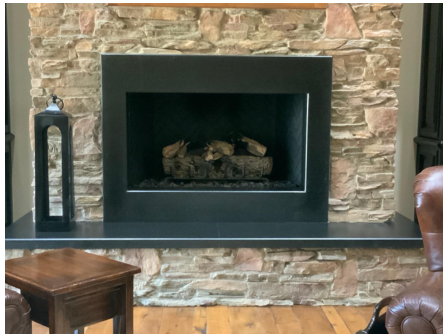
Family Room

s-241: One or more fireplaces were not igniting when tested. Recommend further review and repair as necessary.

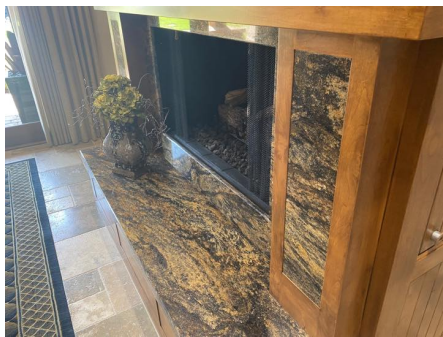
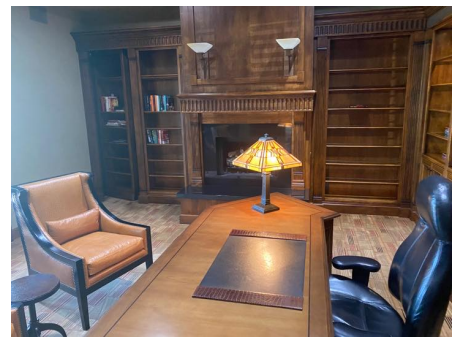
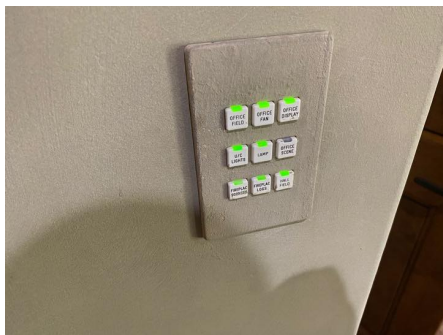
s-242: Automatic igniter in the living room and office is not functioning properly, further evaluation and repair is recommended.

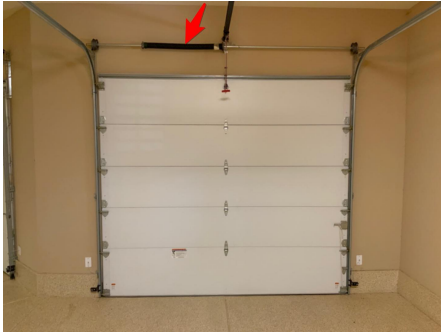
Single bay garage door

s-306: The tension springs are loose or damaged and are not performing as designed. This could shorten the life of the opener motor and is a safety concern. Recommend further review by a garage door specialist.

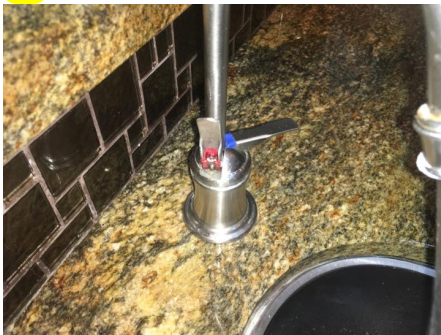
Insta-Hot faucet

WARN s-314: The faucet is leaking. We recommend that it be repaired or replaced.

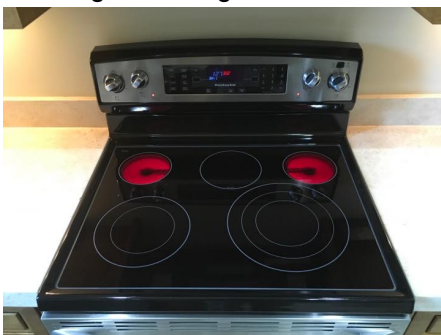
Casita

s-325: Generally, the electric range was found to be in serviceable condition. However, several elements are not working, or are not working to their full capacity. These elements will have to be replaced to allow full use of the range as designed.

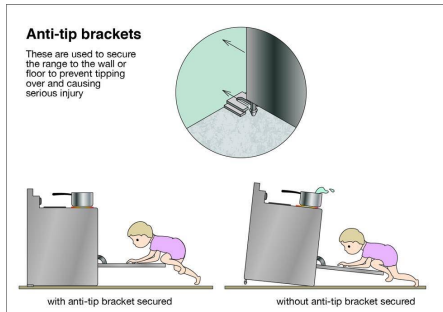
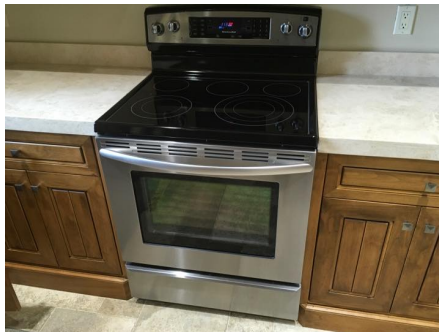
s-326: The casita stove does not have an anti-tip device which is required by the manufacture. This is an important safety device and should be installed immediately.

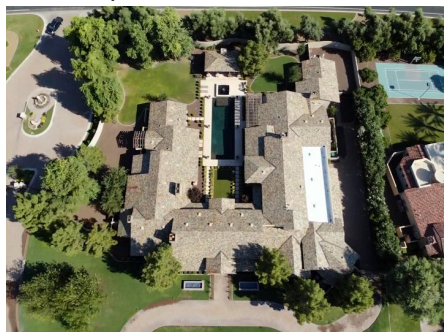
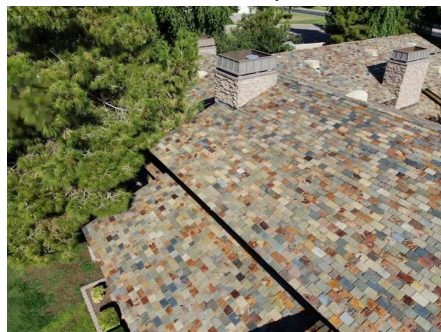
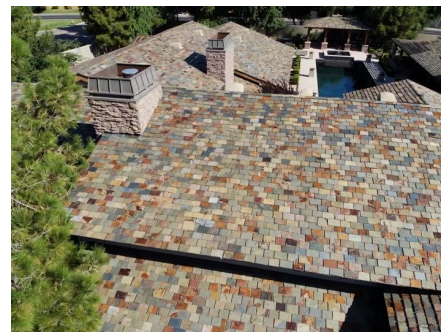
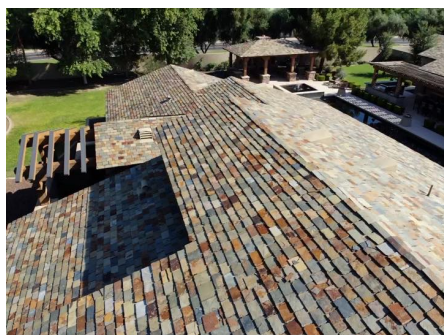
EVAL 18: There are individual cracked, chipped and displaced tiles along the ridge and/or in the field.
Recommend further evaluation.

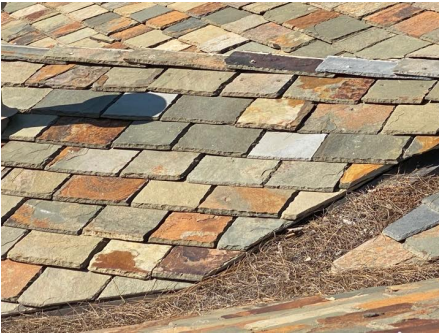
19: There is debris on the roof, requiring removal to prevent accelerated deterioration of the membrane under the tiles. We recommend that the roof be monitored and periodically cleared of debris in the course of routine property maintenance.

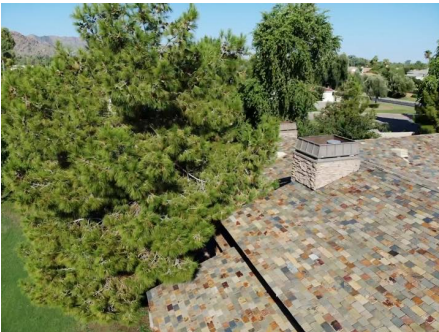
WARN 20: Trees are overhanging the roof. We recommend they be trimmed to prevent debris from accumulating on the roof and to prevent damage by abrasion.

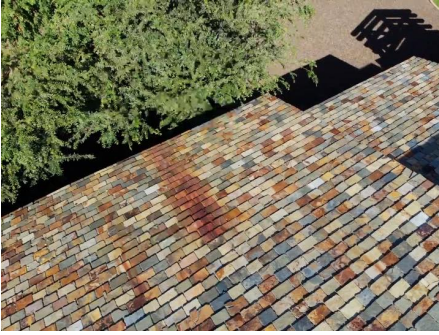
EVAL 21: Stained surface was observed, recommend further evaluation and repair.

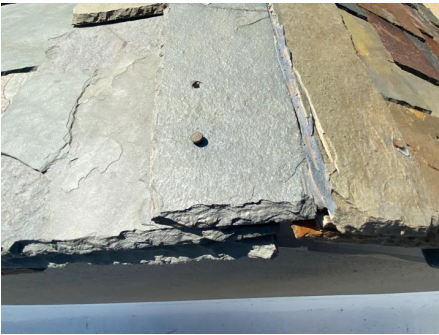
22: Expose metal fastener should be sealed, recommend repair.

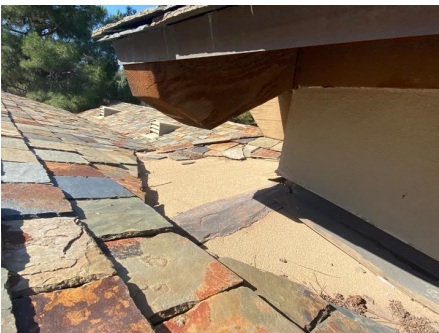
25: The asphalt mastic used as flashing will almost certainly deteriorate before the rest of the roof. Drying and cracking are typical problems. Periodic examination and 'mastic maintenance' is suggested to prevent future leaks.

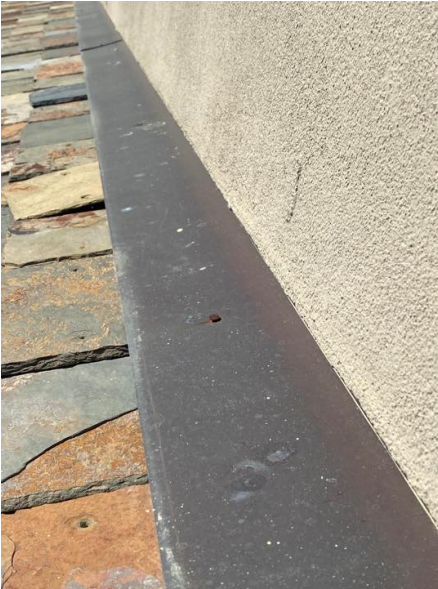
26: The metal fasteners used to secure some flashings are exposed, creating the opportunity for leakage. We recommend all exposed fasteners be sealed with a high quality caulking. Urethane sealants, not silicone, are recommended.

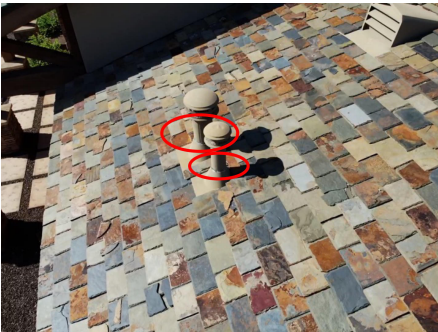
28: There are several missing storm collars. This creates an opportunity for leakage, recommend adding collars.

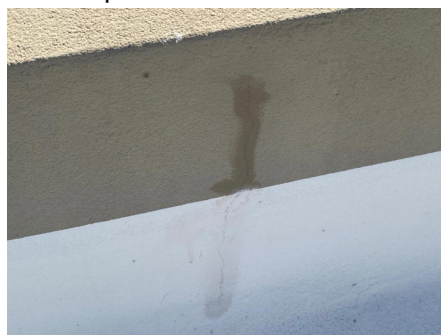
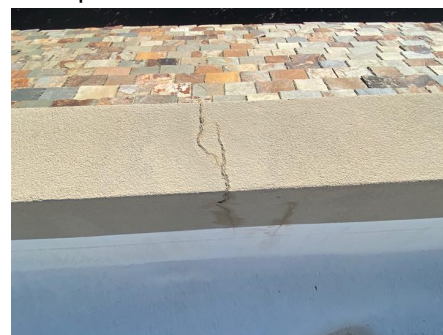
42: The visible surfaces of the parapet are weathered and in need of maintenance. We recommend repair, caulking, sealing and/or replacement of the exposed materials to maintain a waterproof condition.

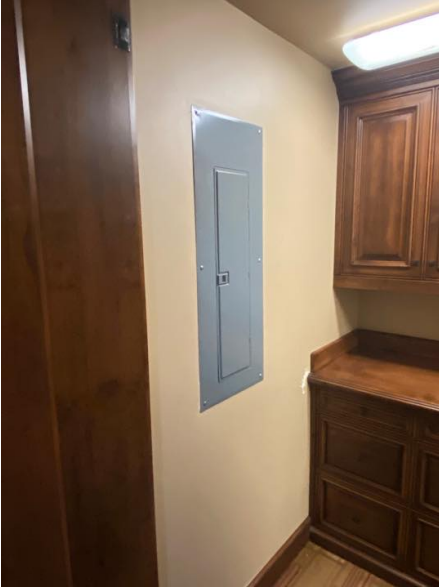
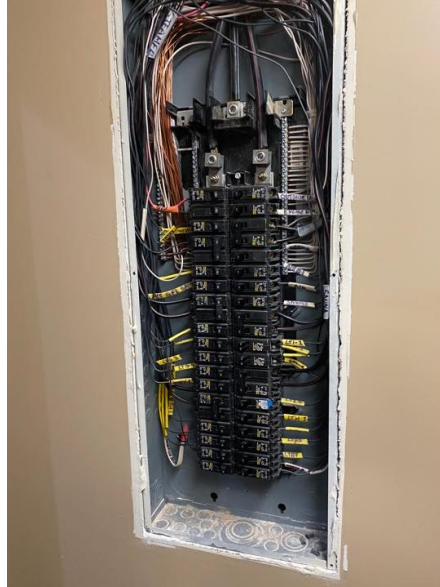
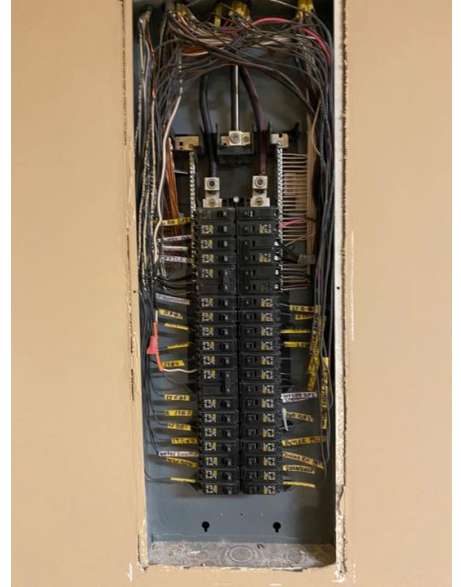
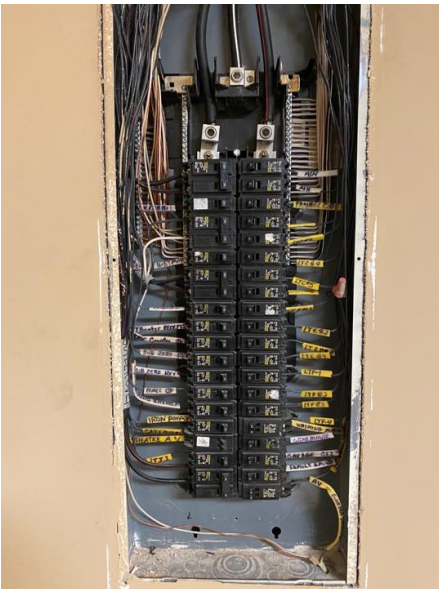
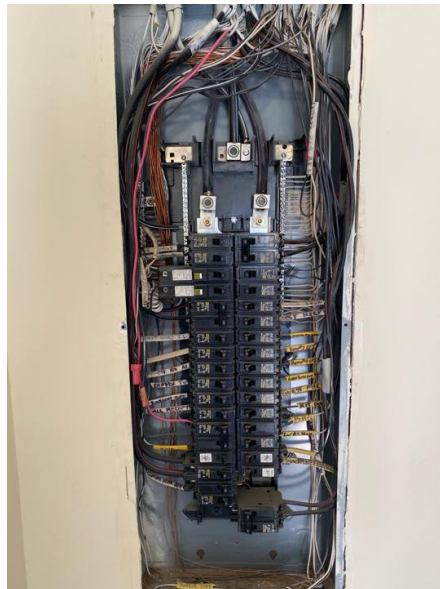
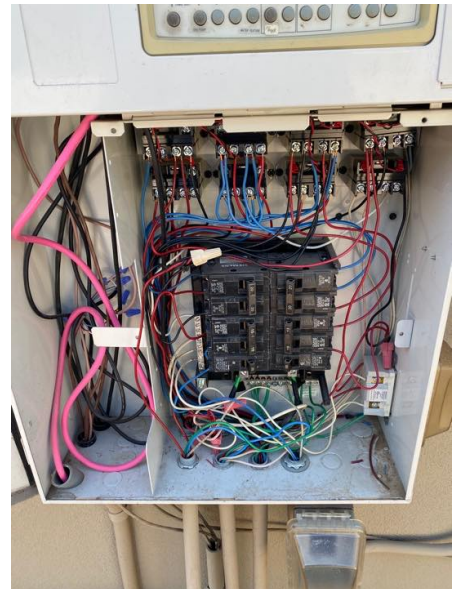
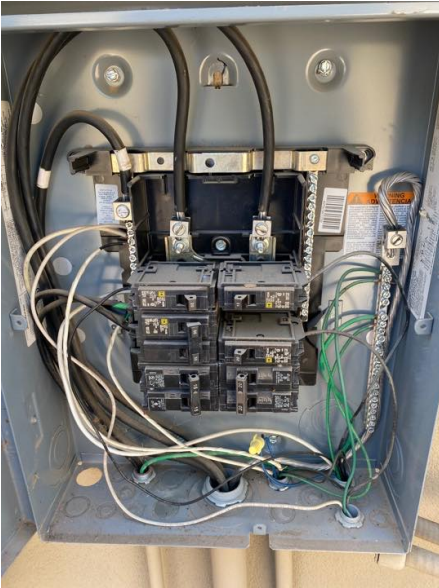
78: There are holes in the subpanel where 'knockouts' have been removed and left open. This is not an approved practice and we recommend the holes be closed with approved filler plates.

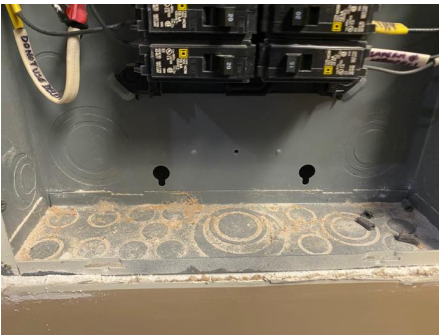
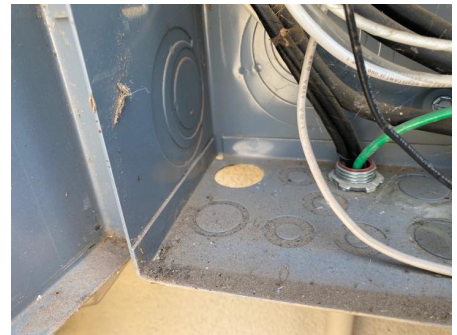
79: Some of the subpanel cover screws are missing. We recommend installation of proper blunt-end screws.

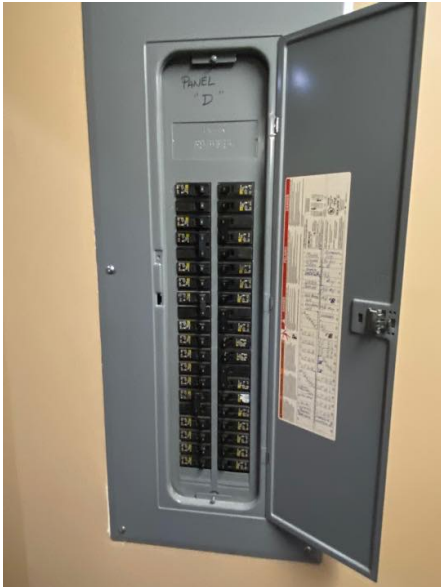
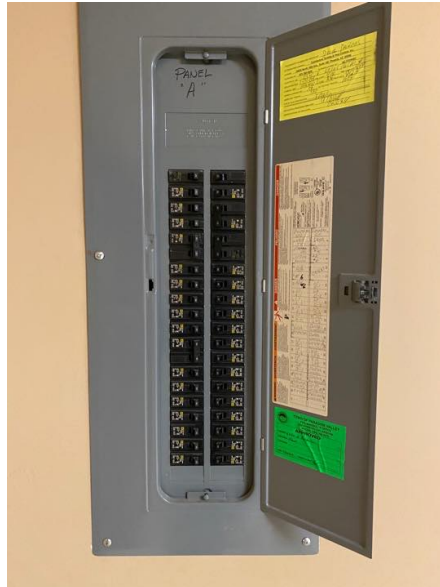
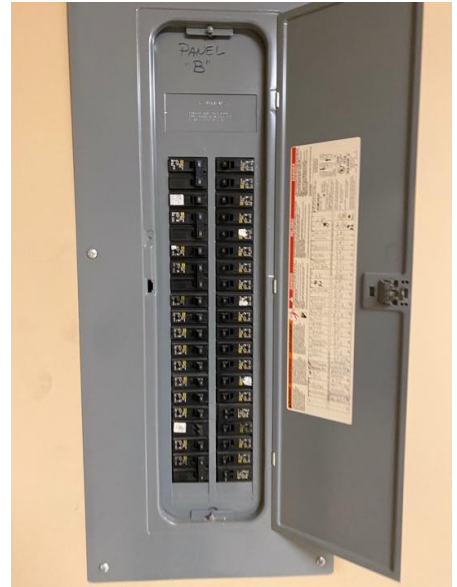
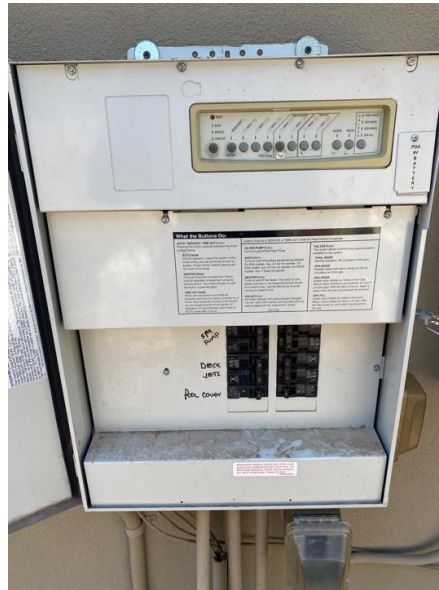
81: Neutral wire in sub panel A has not been properly re identified, recommend wrapping the wire with black electrical tape to identify.

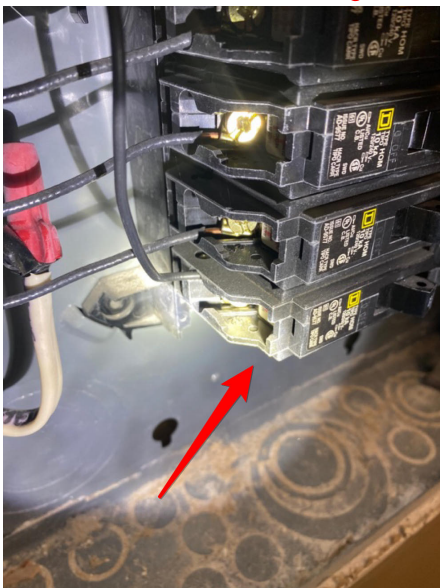
Panel D

DNGR 83: We found over-fusing in the subpanel. This allows excessive current(heat) to flow through the conductors(wire) before the overcurrent protection devices(breakers) 'trip'. This is a safety hazard because it allows conductor overheating.

82: There are significant deficiencies in the subpanel(s). We will not list the numerous reportable conditions because the entire installation needs attention by a professional. We recommend a licensed electrical contractor be retained for repairs.

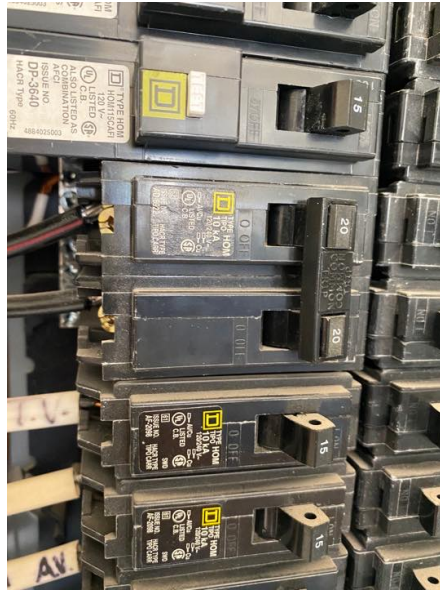
Panel C

84: We found underfusing in the subpanel. This is not a hazard but, depending on the connected loads, may be an annoyance because of frequent and unnecessary tripping of the circuit. We recommend installation of appropriate fuses or breakers.

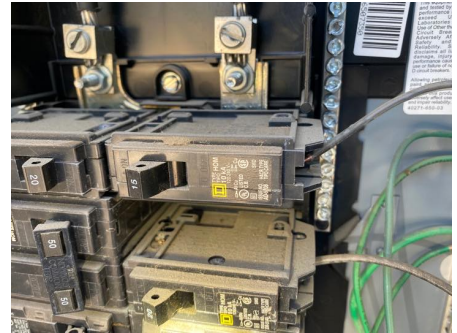
85: Substandard wire installation, recommend repair.

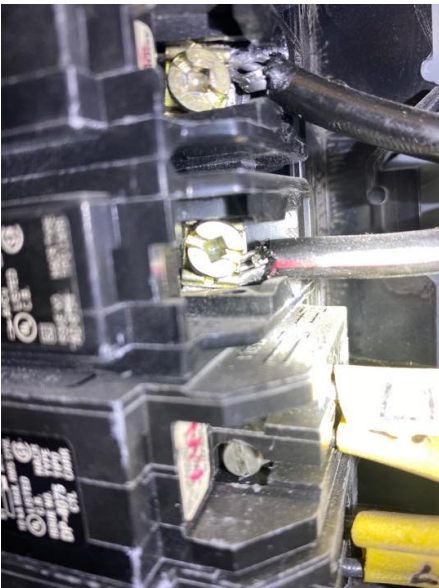
Damaged connections sub D

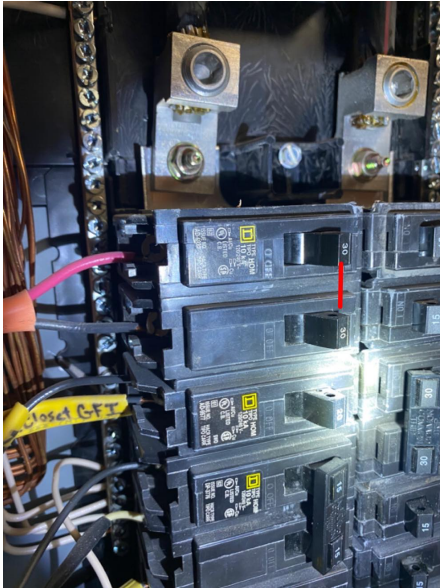
Panel D

86: Missing breaker handle tie, recommend repair.

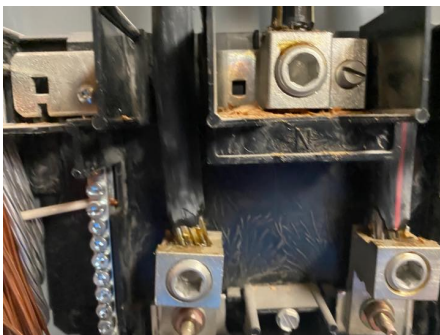
Panel D

WARN 88: The accessible aluminum connections are installed in accordance with standard trade practice, but some lack the application of an anti-oxidant. We recommend that each accessible aluminum connection be covered with an anti-oxidant.

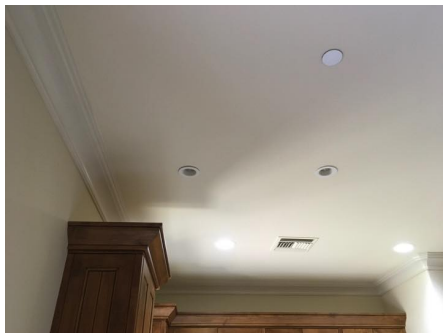
Casita

93: Several lights were not working at the time of this inspection. The bulbs may have burned out. Where bulbs are not the problem, the condition of these fixtures and/or wiring should be verified.

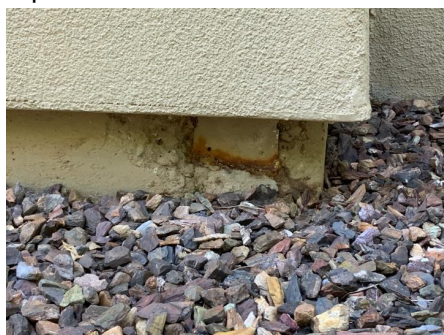
Left Rear Corner

106: Corroded foundation straps were observed around the perimeter. Recommend further evaluation and repair.

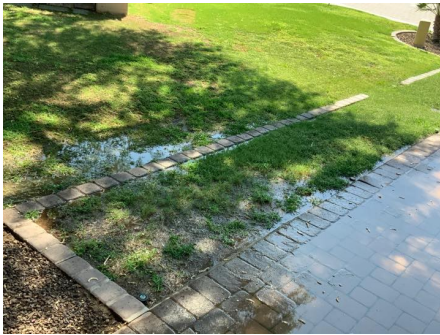
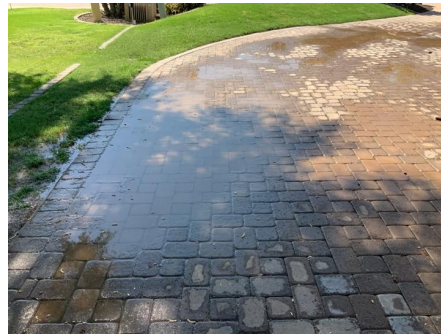
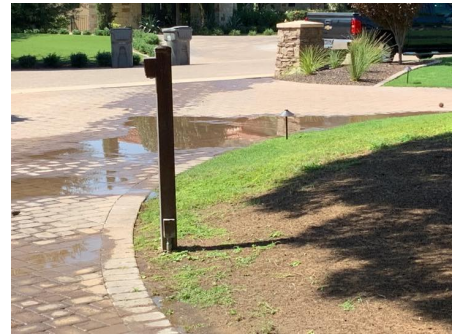
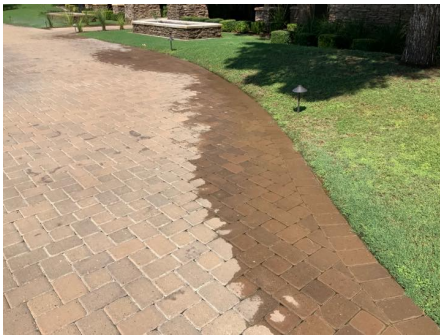
108: Overspray and puddling was observed throughout the property. We recommend repair or adjustment as necessary.

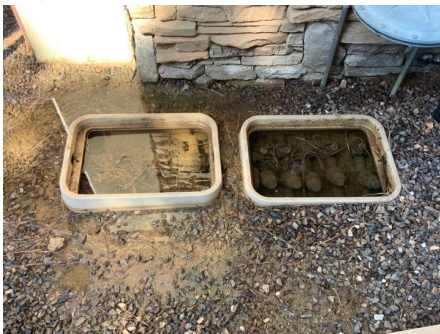
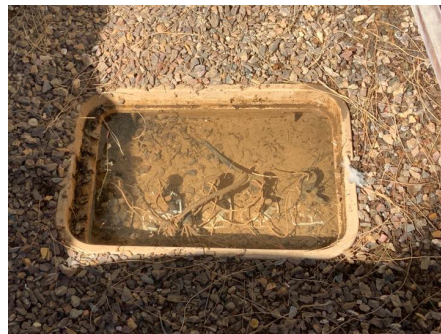
EVAL 109: Leaks were observed in the system at the front irrigation valves. Recommend further evaluation by a irrigation professional and making all necessary repairs before using the system.

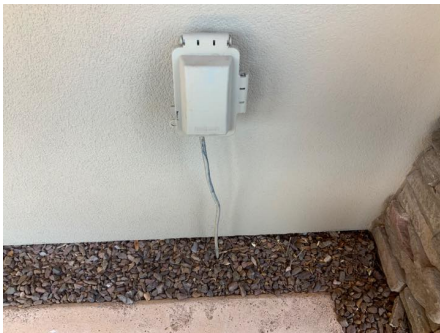
Backyard

111: The buried wiring to the outdoor lighting is not an approved installation. In this case, the wiring is vulnerable to physical damage and should be encased in proper underground conduit. We recommend it be replaced with an approved material.

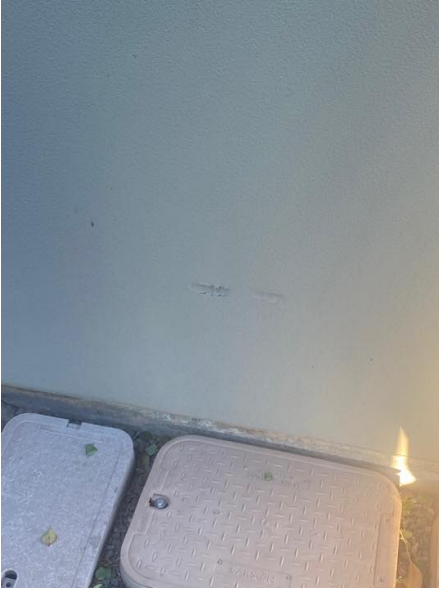
114: Sections of the stucco are damaged or have holes in them. We recommend they be repaired or replaced.

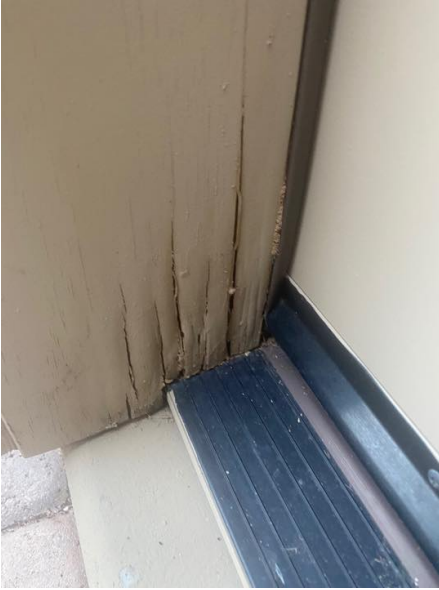
116: The garage exterior door is deteriorated. We recommend it be repaired or replaced.

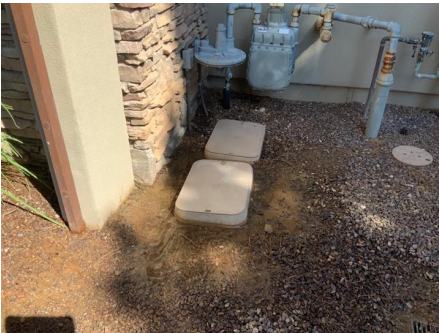
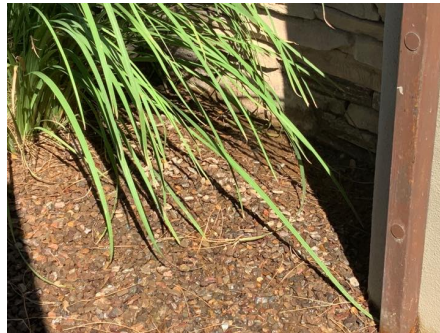
WARN 119: Grading is sloped toward the structure in some areas. Low spots and negative grading promote water accumulation near the building, leading to foundation problems. Regrading would help ensure that surface water flows away from the structure.

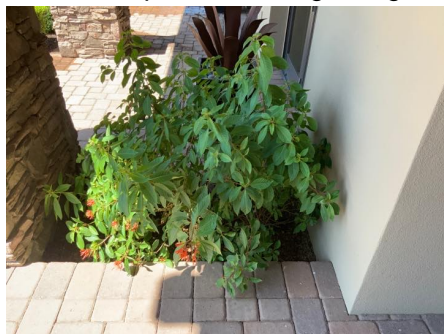
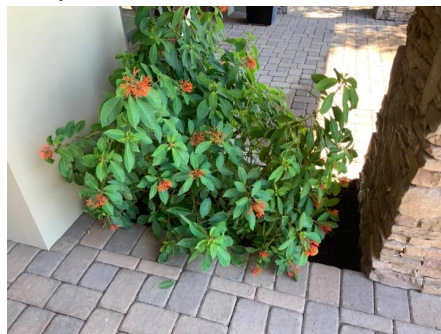
120: Planters and/or areas of high grading can promote water accumulation near the building leading to foundation problems. Regrading would help ensure that surface water flows away from the structure.

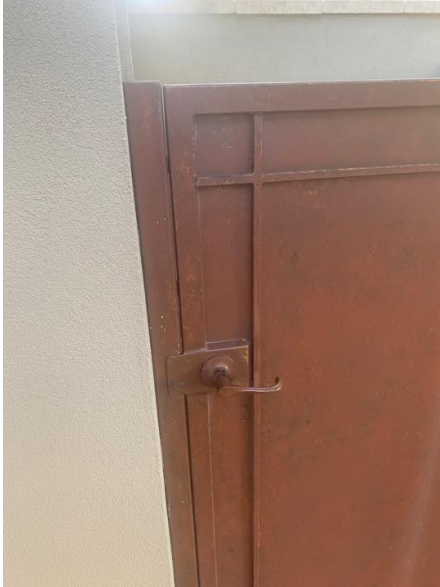
129: The gates are difficult to operate. We recommend repair or replacement.

Rubs

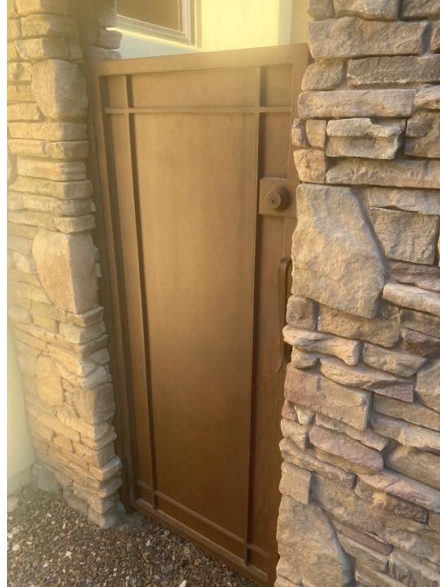
Locked

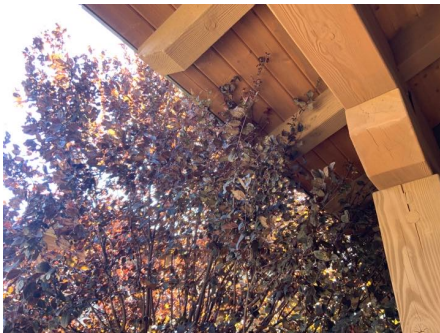
WARN 130: A tree or bush is touching the structure. We consider this a potential threat to the structure. To eliminate the potential for damage, we recommend modification of the structure to accommodate the tree or removal of the tree.

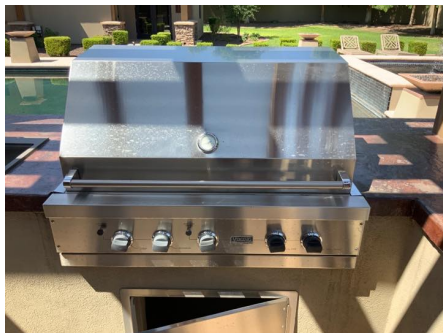
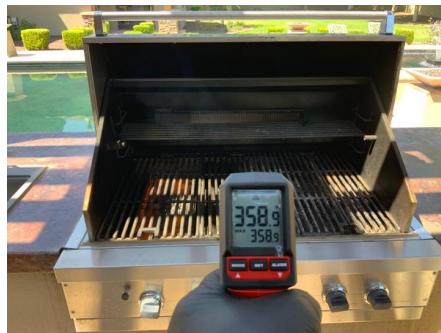
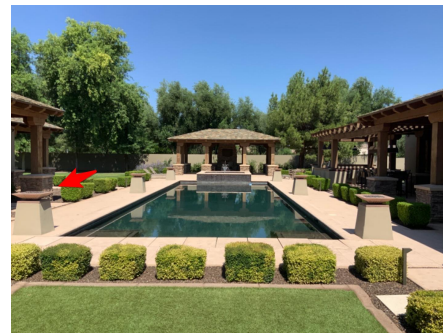
135: All gas fired accessories, including barbecues and/or fire pits, are beyond the scope of this inspection. However, we test these units as a courtesy for operational or safety issues. Everything was operational except the front left fire pot.

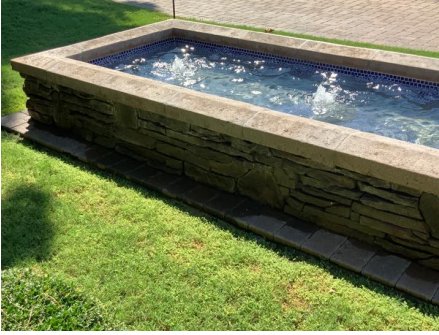
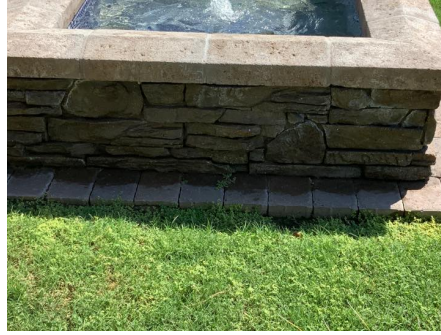
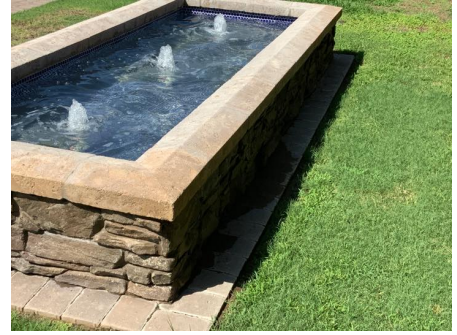
137: Although fountains are not part of a standard home inspection, it appears they are leaking. Recommend further evaluation and repair as necessary.

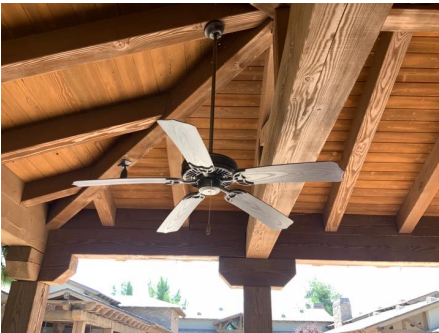
Ramada

139: One or more outdoor fans were not operational or the remote was not located. Recommend further review and repair as necessary.

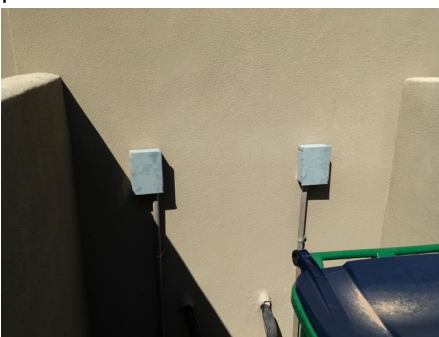
Right side

160: There is no local disconnect in view of the equipment. We recommend that one be installed as required by present standards.

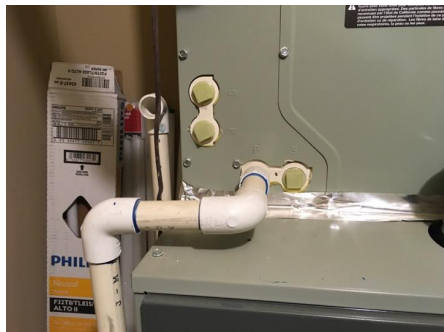
Garage

WARN 164: The secondary condensate drain line lacks a drain fitting in the air handler that allows condensate to properly drain into the catch pan, should the primary drain become plugged up. We recommend modification in accordance with present standards.

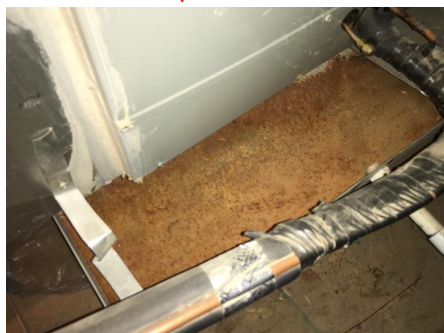
165: Rust was observed in the attic drip pan indicating a prior need for service. No issues were observed at the time of the inspection. Recommend obtaining receipts from seller on repairs made.

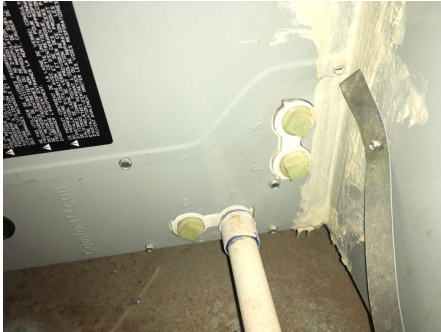
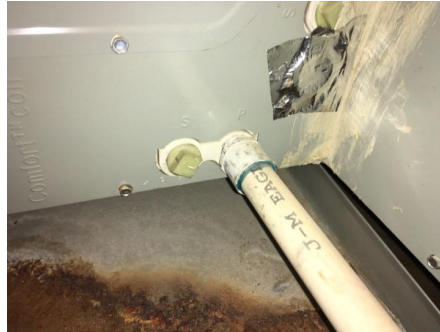
167: Air handlers located in interior attic space or closets need to have the condensation lines flushed annually. These lines get clogged with debris and are one of the leading causes for interior water damage. Adding a float switch or moisture sensor on the secondary drain line or into the catch pan is highly recommended.

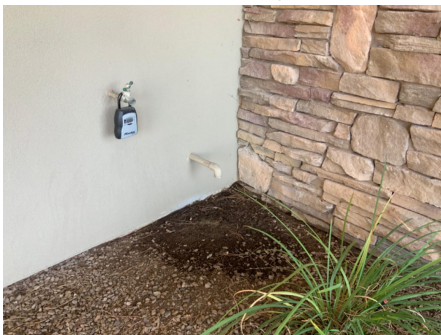
Front

168: The condensate drain lines are draining to close to the foundation and causing minor damage. Recommend re-routing away from the foundation.

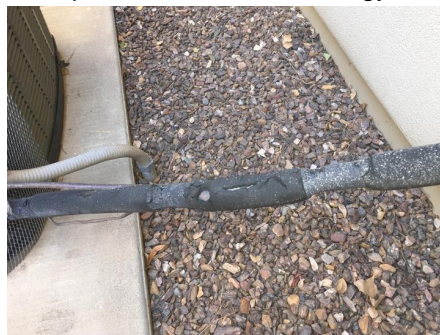
Left rear

169: Insulation is deteriorated and missing from a portion of the refrigerant lines near the condensing unit. We recommend that all missing insulation be replaced to increase energy efficiency.

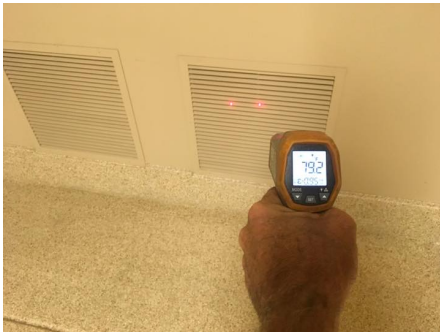
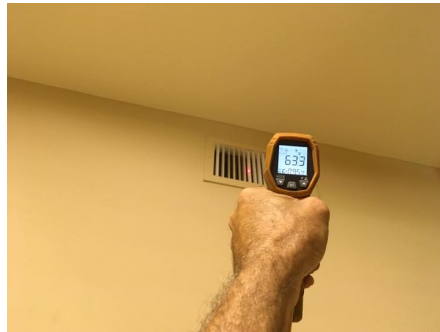
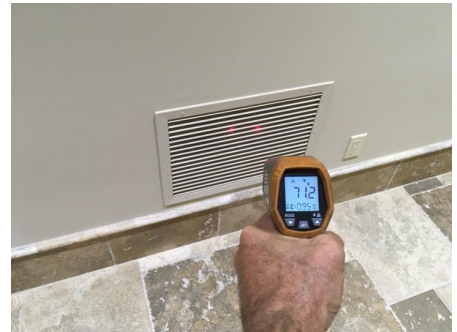
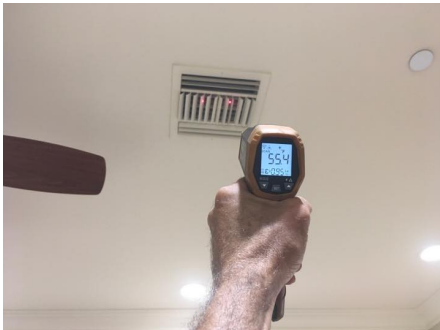
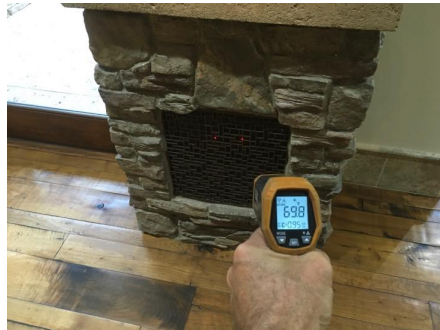
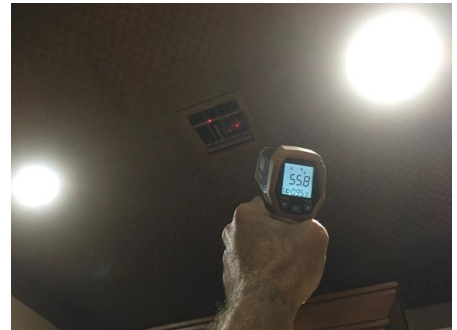
Right front: 13°F - Further evaluation recommended

Left front: 13°F - Further evaluation recommended

Master suite: 7°F - Further evaluation recommended

Left rear: 13°F - Further evaluation recommended

Casita: 17°F

EVAL 174: For further evaluation and/or attention to the condition(s) noted, we recommend the advice and services of a licensed air conditioning contractor.

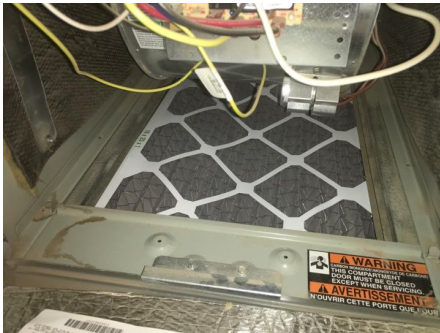
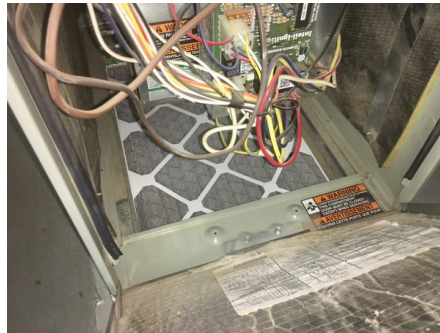
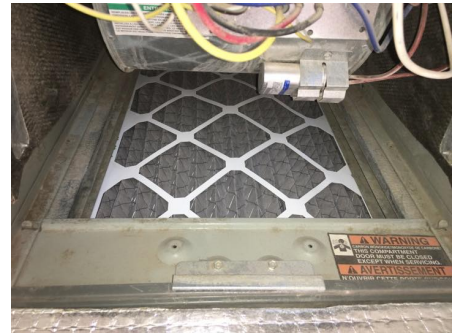
190: The filters have accumulated debris which decreases their effectiveness and blocks air flow. This can dramatically decrease the efficiency of the heating system. We recommend the filters be removed, cleaned and replaced if necessary.
