Confidential Inspection Report

LOCATED AT:
6370 E Royal Palm Rd
Paradise Valley, AZ 85253

INSPECTED ON:
Monday, September 13, 2021

Inspector, Rich LeGrand 53350
Alliance Property Inspections 14747 N. Northsite Blvd Set 111-292 Scottsdale, AZ
85260

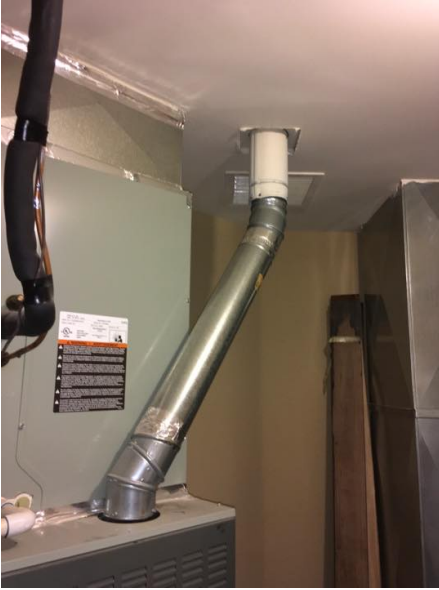
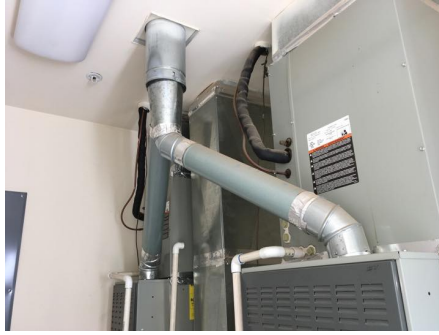
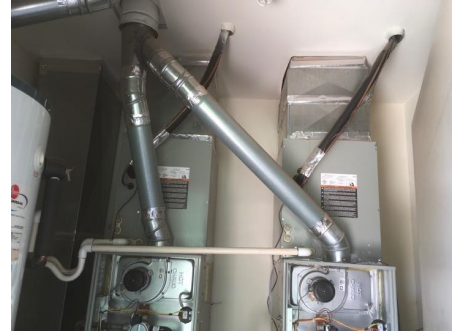
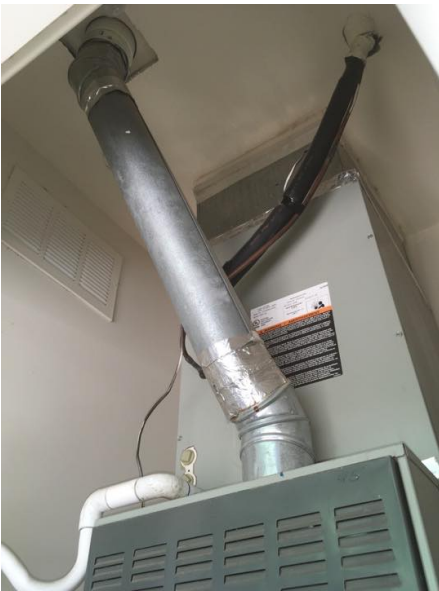
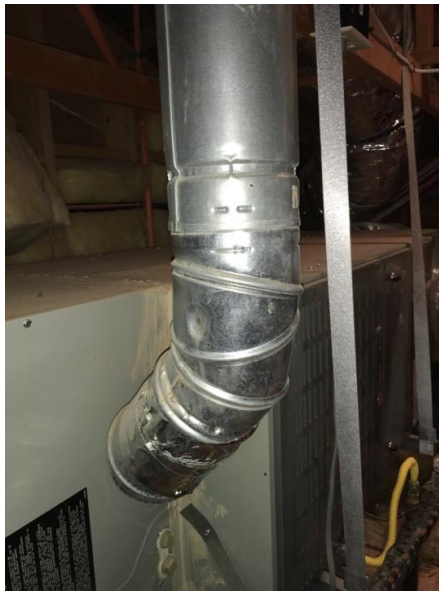
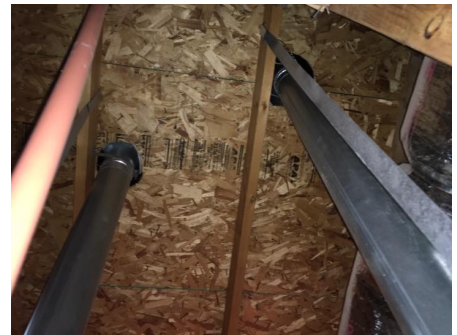
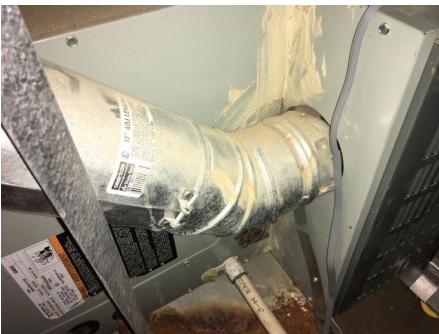
191: The heating system vent is properly installed and appears in serviceable condition where seen.

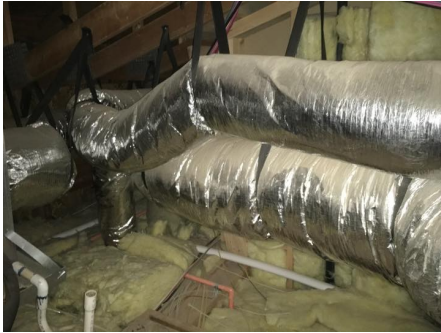
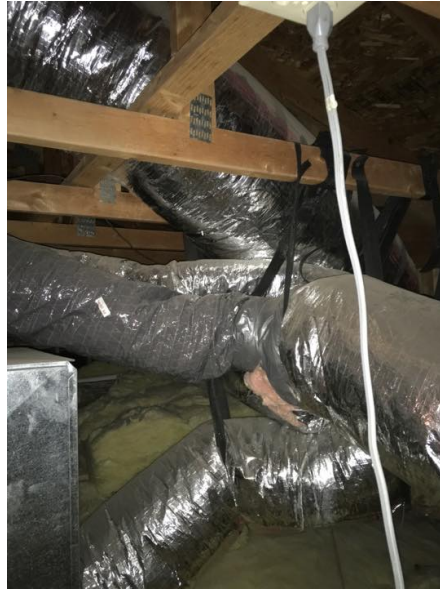
194: The ducts appear to be generally properly installed and are in serviceable condition, with exceptions noted below.

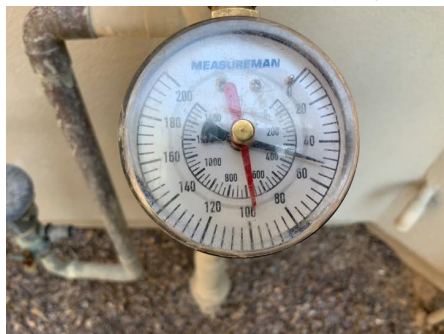
- 201:** Domestic water source: Public supply
- 202:** Landscape water source: Public supply
- 203:** Main water line: Copper
- 204:** Supply piping: Copper where seen
- 205:** Waste disposal: Indeterminate
- 206:** Waste piping: Plastic where seen
- 207:** Water pressure: Mid-range of normal water pressure

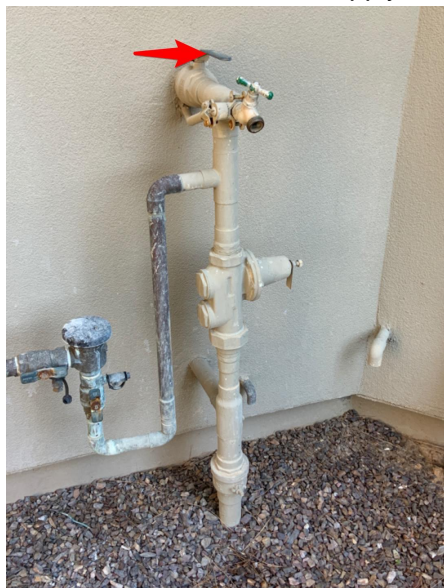
- 210:** The domestic water supply main shut-off valve is outside at the front of the building.

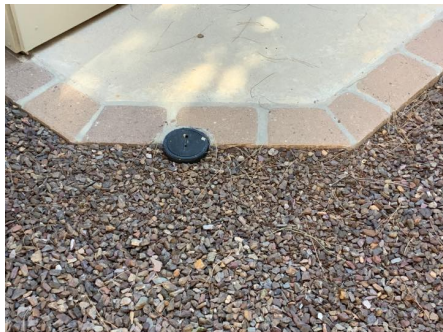
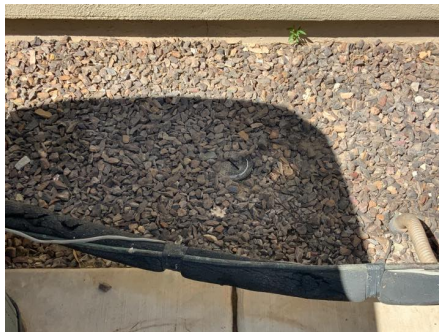
218: The sewer cleanout is located at the front and right side of the structure.

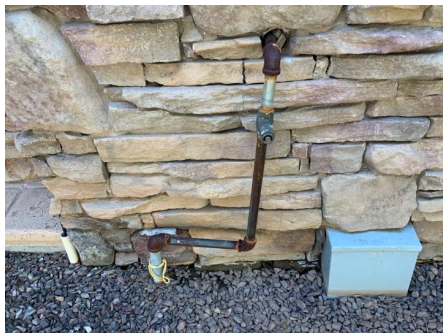
222: Portions of the gas piping near the meter and the patio fireplace are corroded and rusted. We recommend they be prepared and painted with an approved weatherproofing material.

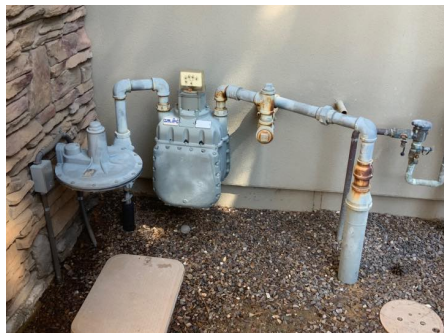
223: The gas meter is outside at the front of the building. The main gas supply shutoff valve is located on the riser pipe between the ground and the meter. This valve should be turned 90 degrees (either way) in order to shut off the gas.

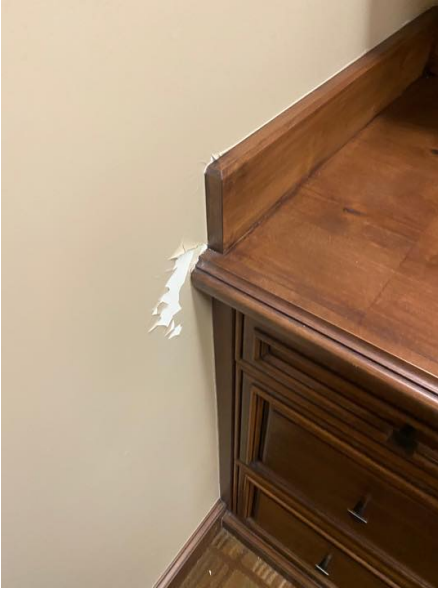
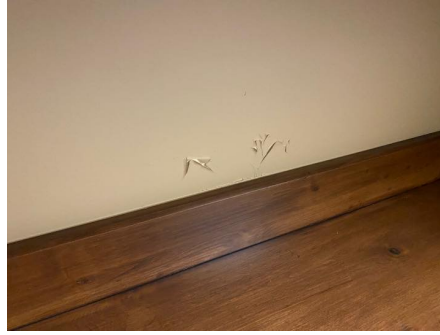
228: The interior wall and ceiling blemishes are cosmetic and can be repaired in the course of routine maintenance.

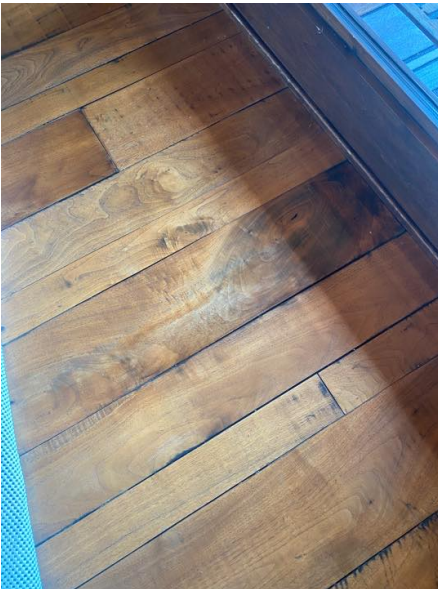
230: Portions of the floors are worn. We recommend refinishing to protect the wood and for a better appearance.

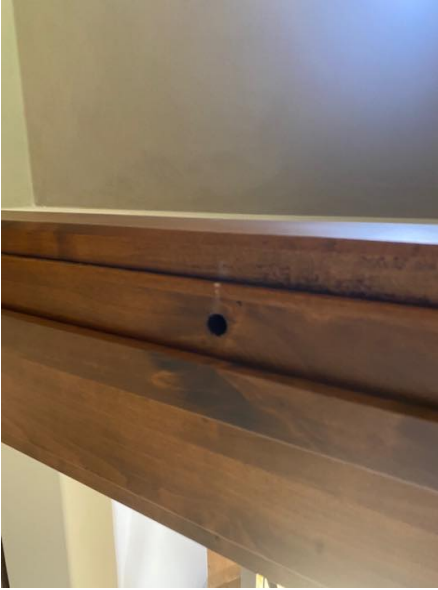
Office

234: Several of the doors have loose or missing hardware. We recommend that hinges, latches, and strike plates be adjusted or replaced to restore full operation.

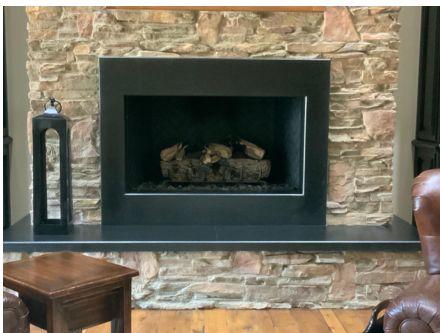
Family Room

241: One or more fireplaces were not igniting when tested. Recommend further review and repair as necessary.

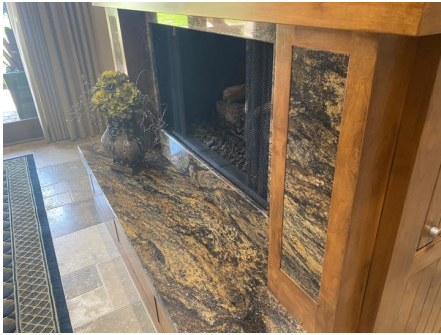
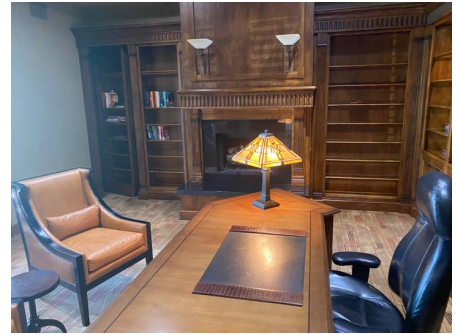
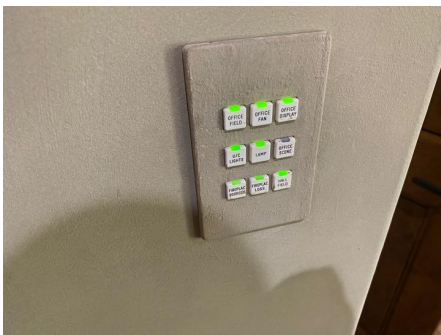
242: Automatic igniter in the living room and office is not functioning properly, further evaluation and repair is recommended.

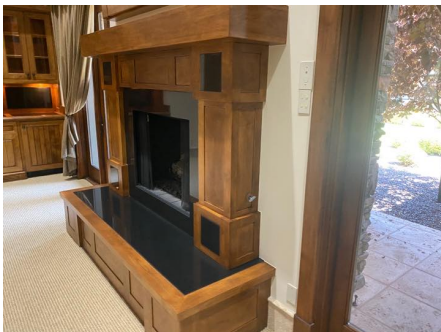
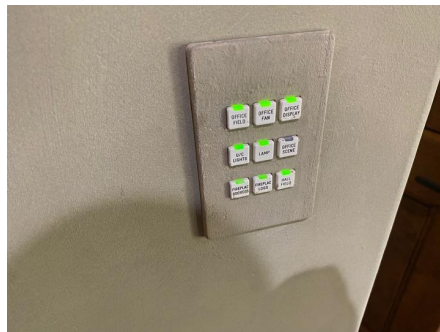
243: Master bedroom fireplace did not operate by the wall switch, recommend further evaluation and repair.

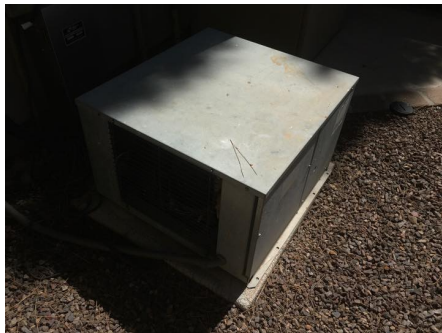
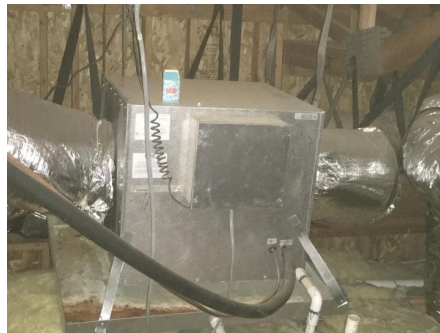
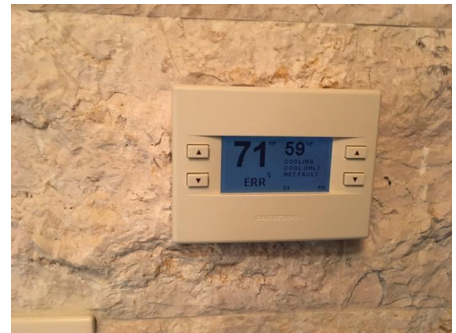
252: The wine cellar cooling system appears to be functioning properly. However, rust was observed in the condensate pan in the attic. We recommend further evaluation of the unit by a qualified HVAC professional.

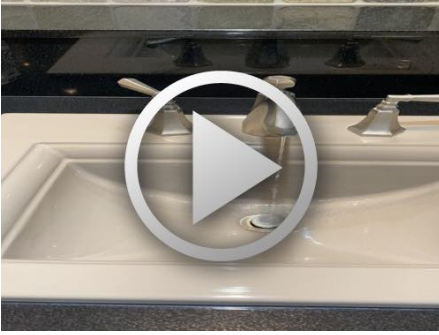
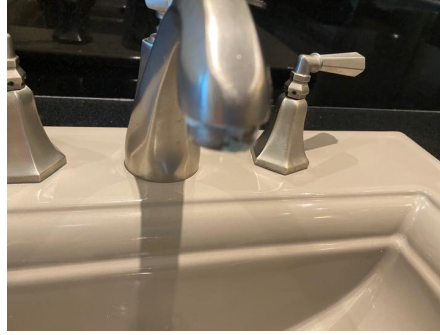
275: The master faucets are leaking. We recommend they be repaired or replaced.

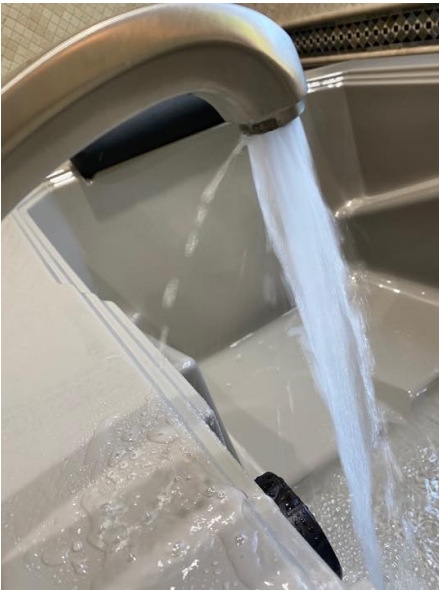
276: Master tub fixture aerator is deteriorated, recommend repair.

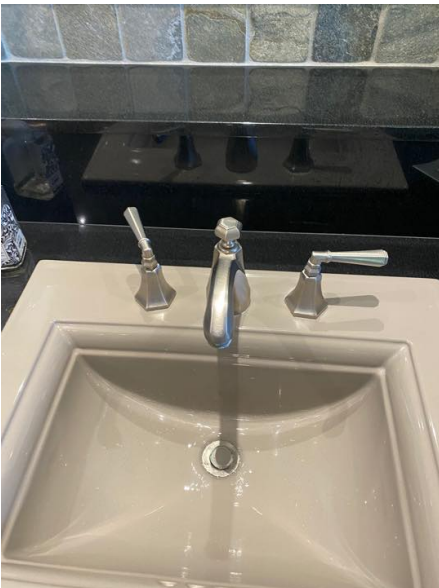
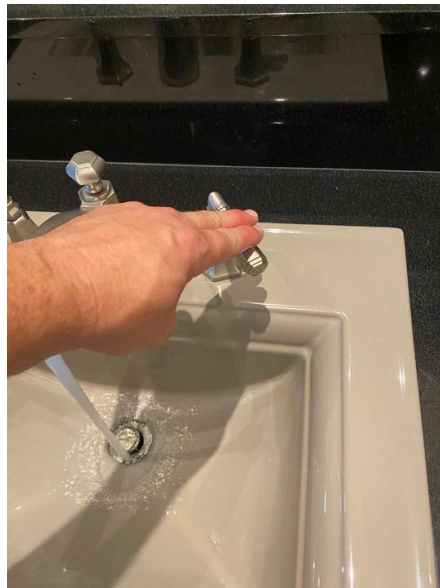
277: Master bath fixture needs adjustment, recommend repair.

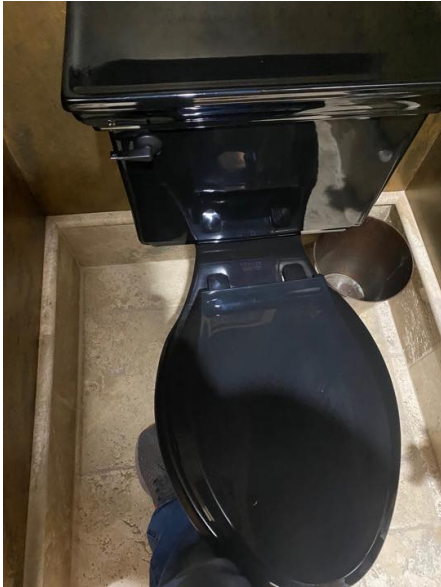
Office

WARN 280: The toilet is loose at the floor. While no damage was evident, this condition should be taken care of so that leakage does not develop and cause damage. We recommend that the toilet be removed and rebolted with a new wax seal.

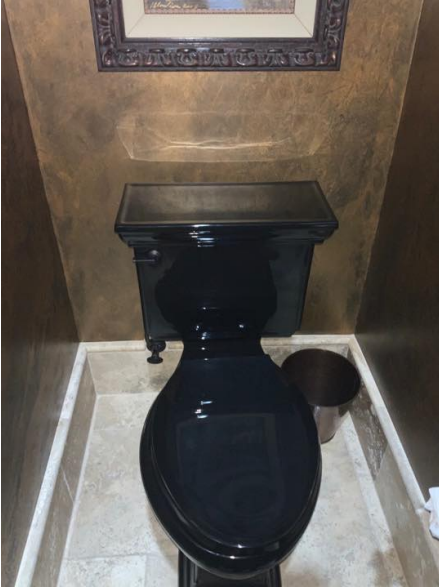
Office

282: The toilet tank is loose. We recommend it be tightened.

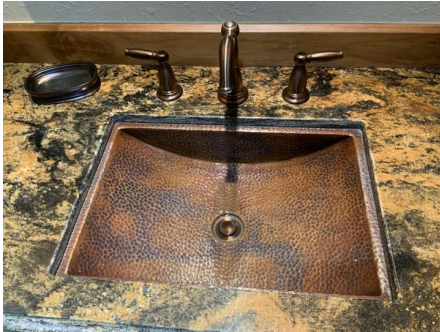
Front half bath

285: The drain stop is defective. We recommend it be repaired or replaced.

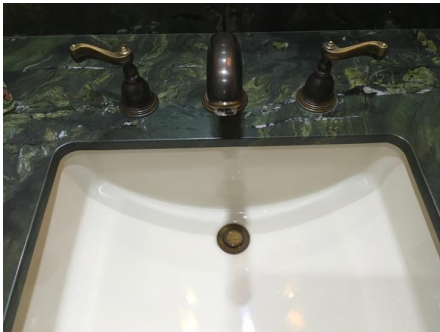
Casita

286: The drain stop is defective. We recommend it be repaired or replaced.

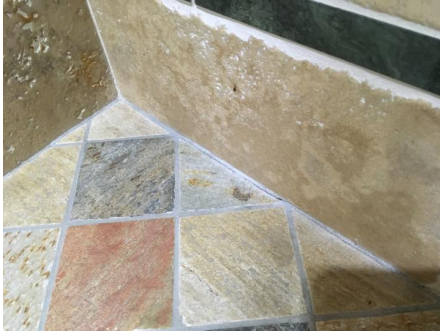
Casita

297: The joint caulking in and around the shower is in poor condition. The enclosure should be recaulked to prevent moisture penetration into the surrounding materials and subsequent damage.

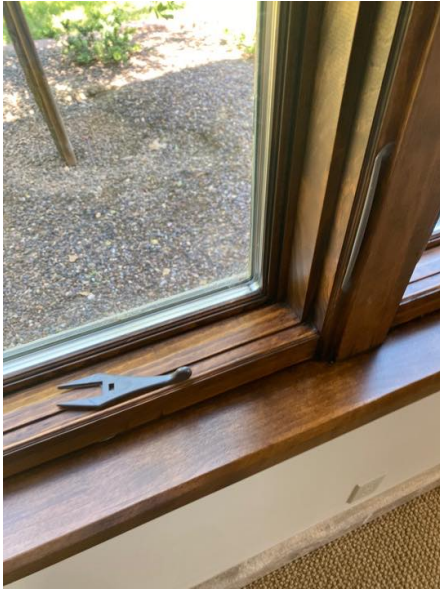
Master

300: There is a broken and/or missing latch on one of the windows. We recommend the hardware be repaired or replaced.

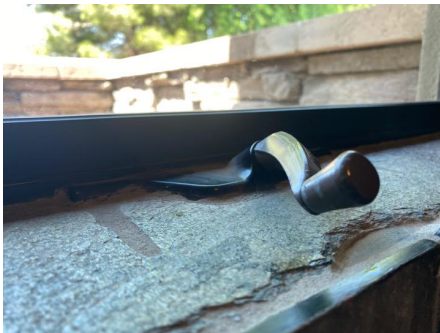
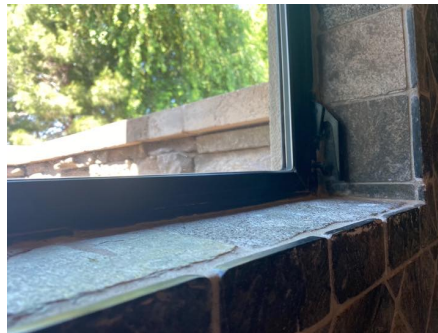
301: Master shower window it's difficult to operate, recommend repair.

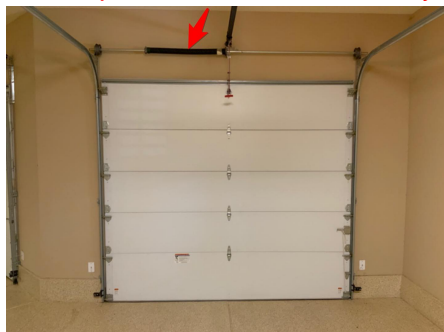
Single bay garage door

306: The tension springs are loose or damaged and are not performing as designed. This could shorten the life of the opener motor and is a safety concern. Recommend further review by a garage door specialist.

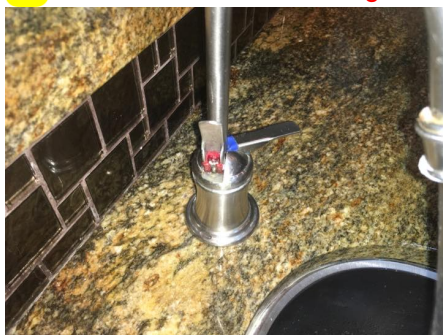
Insta-Hot faucet

WARN 314: The faucet is leaking. We recommend that it be repaired or replaced.

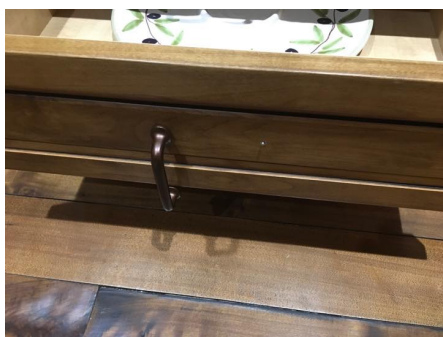
Butler pantry

319: A knob on one cabinet door is broken or missing. We recommend it be replaced.

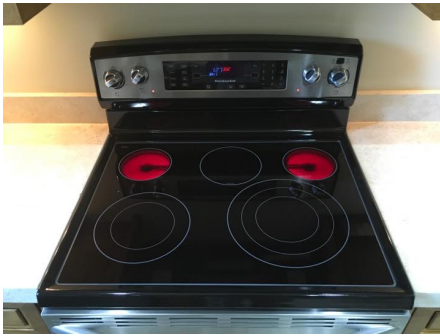
Casita

325: Generally, the electric range was found to be in serviceable condition. However, several elements are not working, or are not working to their full capacity. These elements will have to be replaced to allow full use of the range as designed.

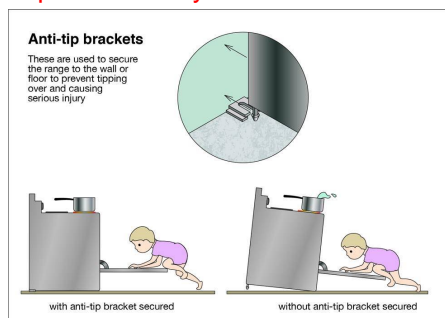
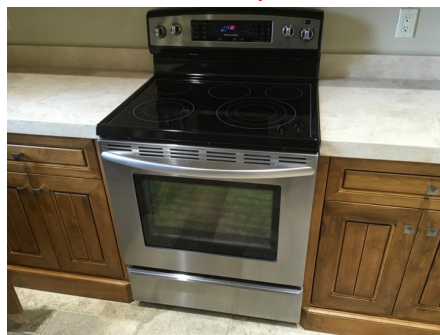
DNGR 326: The casita stove does not have an anti-tip device which is required by the manufacture. This is an important safety device and should be installed immediately.

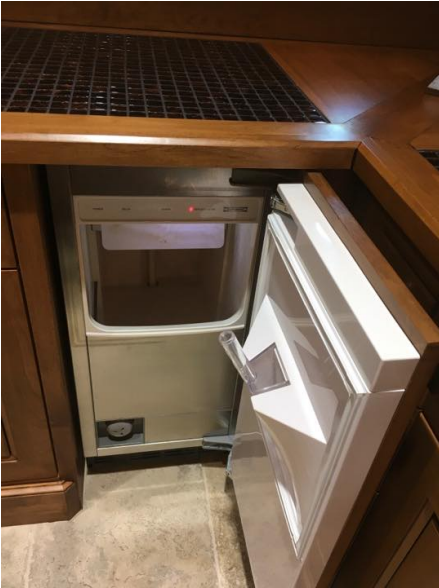
332: The icemaker was off or not functioning. Recommend further review and repair as necessary.

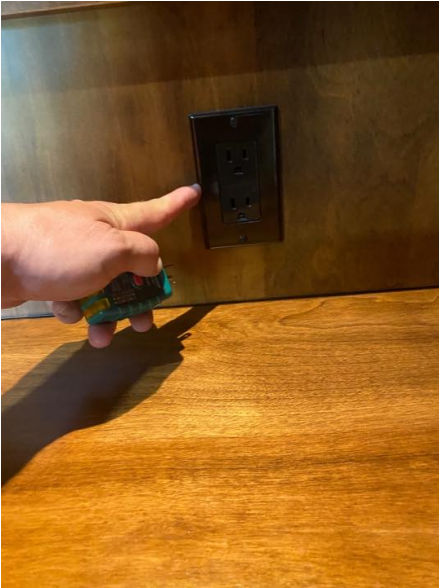
334: A receptacle located at office is loose. For maximum safety we recommend that it be tightened.

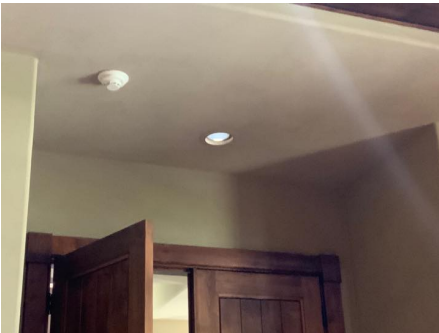
Office

335: The light flickers, probably a result of a loose wire or a defective switch. We recommend the switch be tightened or replaced.

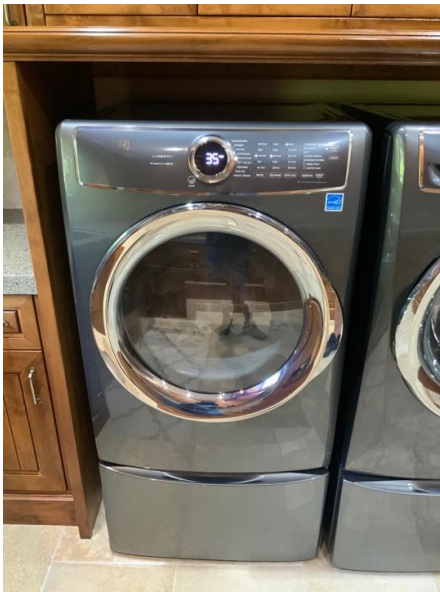
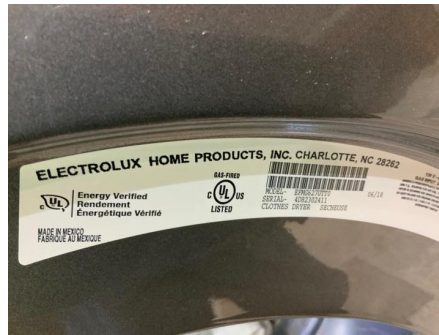
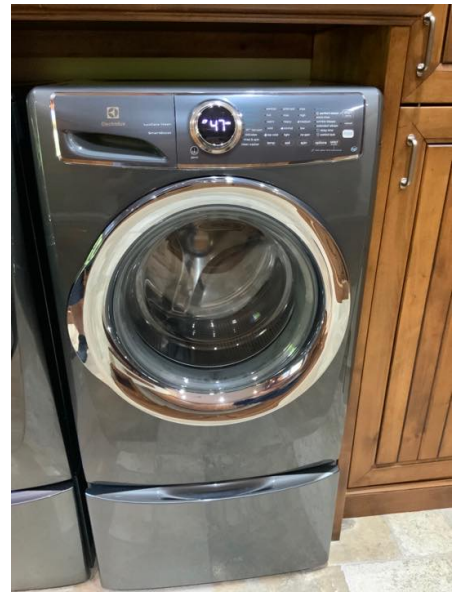
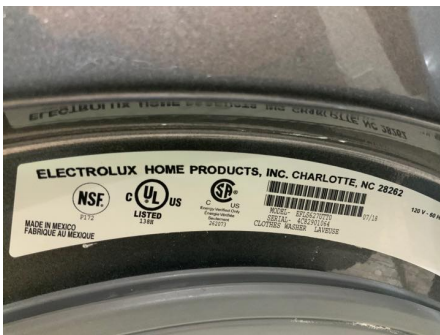
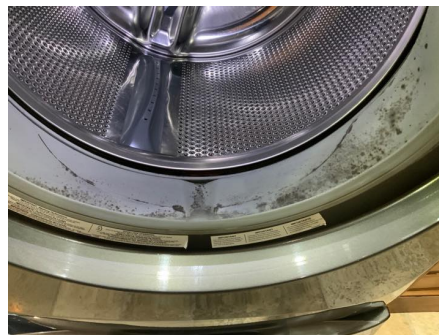
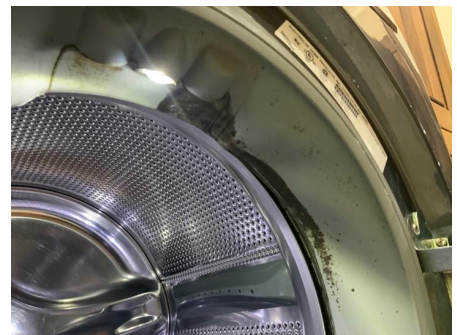
342: The hookups for the washer and dryer were inaccessible and not inspected. However, the units were operated through partial cycles and we observed no issues during the test.

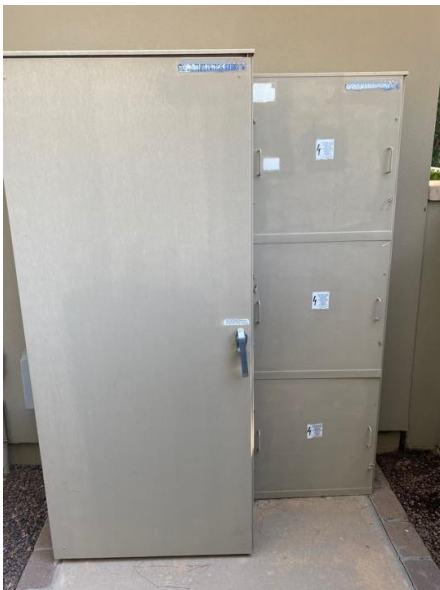
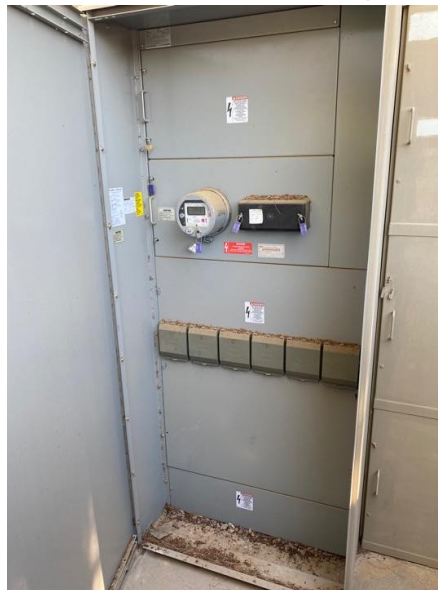
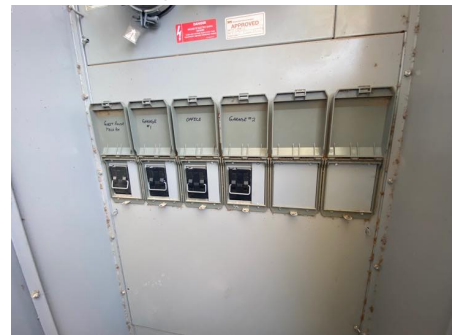
METER & MAIN ELECTRICAL SYSTEM

1: The meter and main electrical service panel are outside on the right side of the building.
